# Voting Accessibility in Massachusetts: 2024 General Election

Report by  
Disability  
Law  
Center,  
Inc.

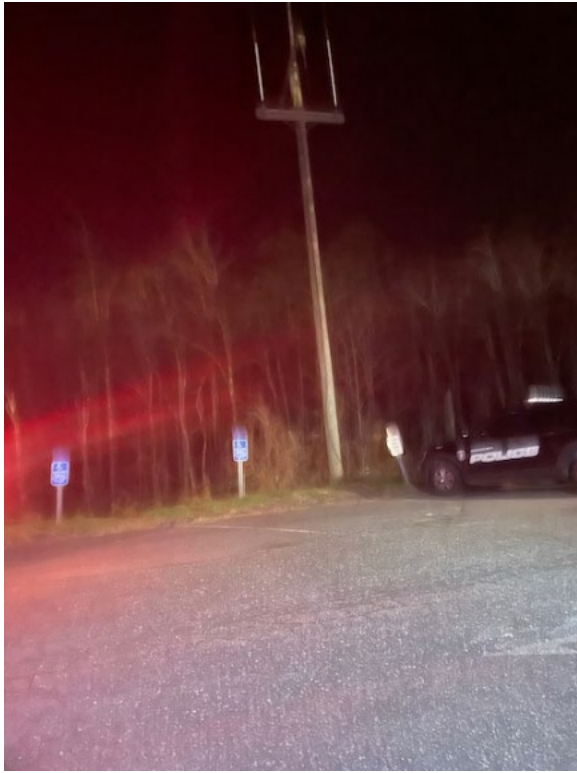
### Becket Town Hall Photos

Partial view of the Becket Town Hall parking lot at night. There are two accessible spaces with signs posted lower than four feet above ground. The parking lot striping is very faded.

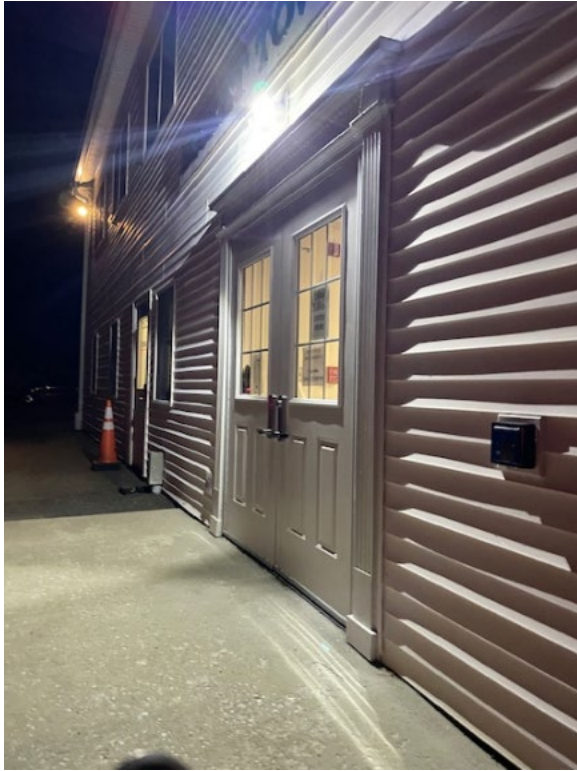
The Becket Town Hall entrance at night. There are two large white doors with lever hardware and bright lights shining above the entrance. There is a push button on the building to the right side of the doors, which the surveyor reported was not functioning at the time of their arrival.

| Polling Place, Municipality | Area(s) of Concern | Issue(s) Identified | Law(s) /Regulation(s) | Suggestion(s) |
|---|---|---|---|---|
| | 2. Entrance | 2.1 The automatic door opener is very loose. | ADA Accessibility Guidelines <a href="#">§404.3.5</a> | 2.1 Door and gate controls must be compliant as operable parts (operable with one hand and without tight grasping, pinching, twisting of the wrist, or more than five pounds of force). |

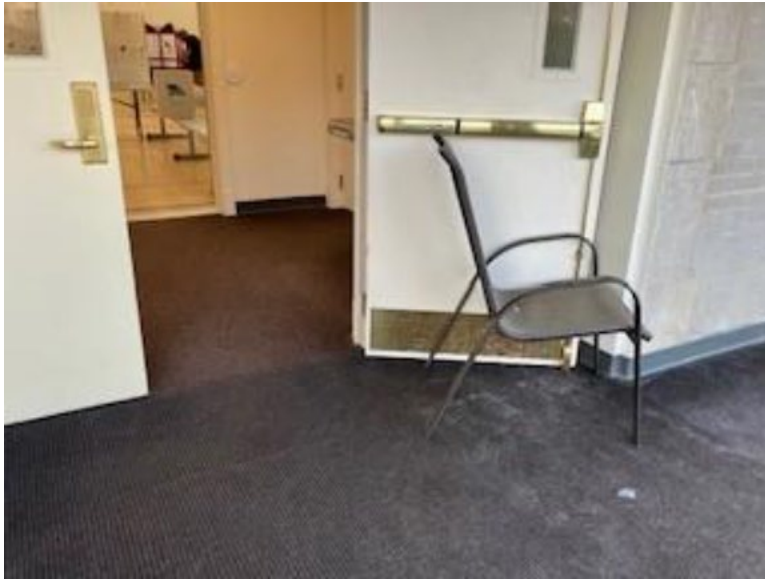
## Lee Crossway Village Photos

A chair props the door open leading to a hallway and separate room with a voting area. The chair partially blocks the path of travel leading inside the polling place.

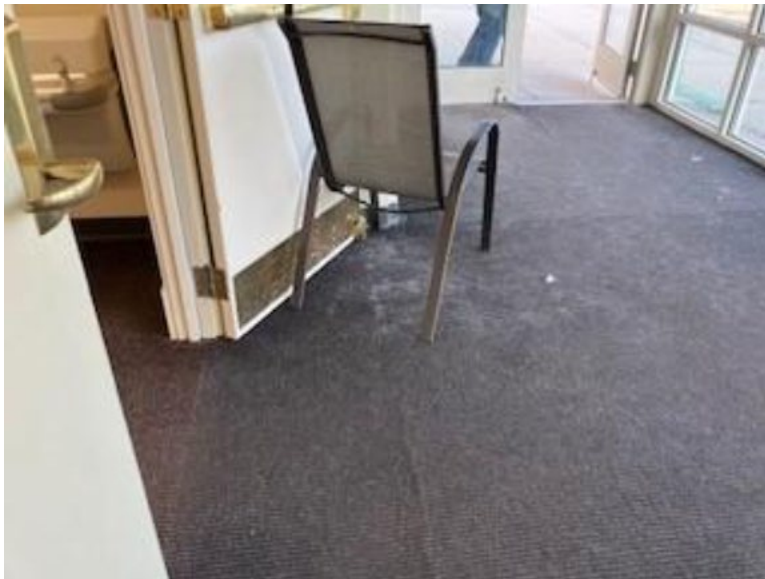
Side view of chair propping a door open to the voting area. The chair partially blocks the path of travel.

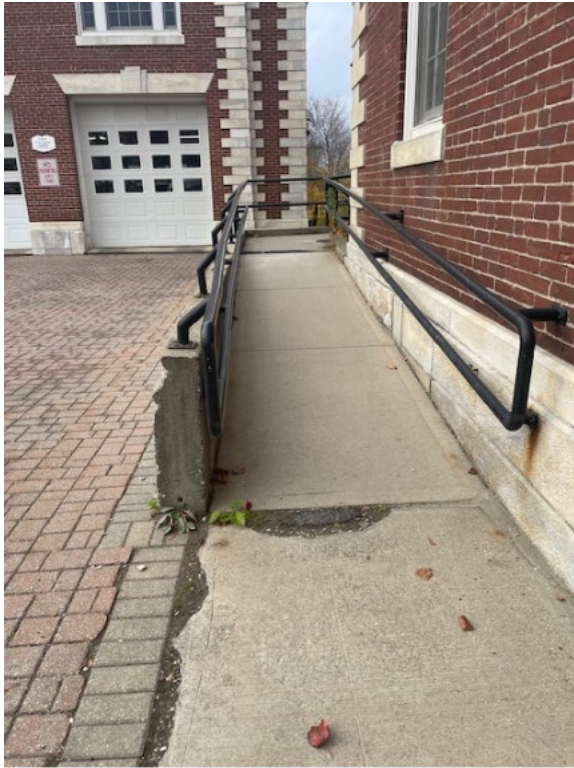
## Lenox Town Hall Photo

Lenox Town Hall ramp leading to the accessible entrance. There are cracks in the cement at the bottom of the ramp creating abrupt changes in level greater than  $\frac{1}{2}$  inch.

| Polling Place, Municipality | Area(s) of Concern | Issue(s) Identified | Law(s) /Regulation(s) | Suggestion(s) |
|---|---|---|---|---|
| Lenox Town Hall, Lenox | 1. Exterior Path of Travel | 1.1 There is broken cement that creates a large crack/abrupt change in level at the bottom of the ramp. (See <a href="#">Lenox Town Hall Photo</a> ) | 950 CMR 51.02(1) | 1.1 Paths of travel should be common, continuous surfaces uninterrupted by abrupt changes in level greater than ½ inch. |

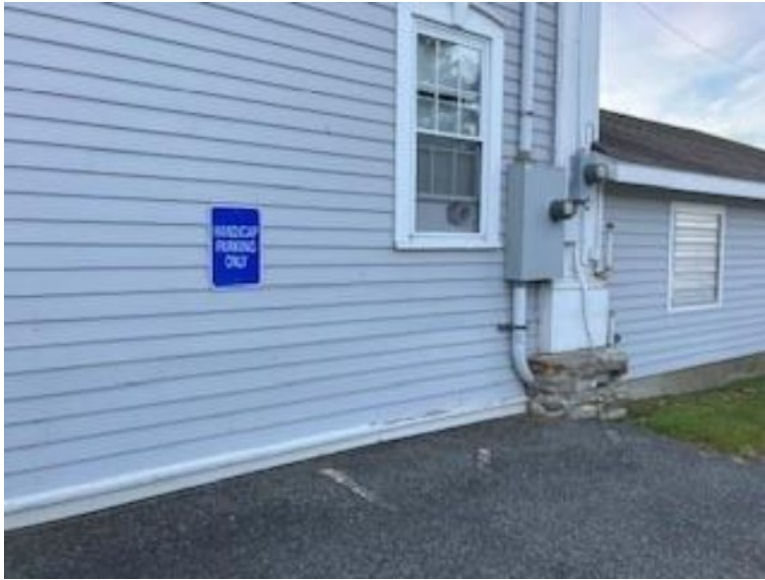
## Tyringham Town Hall Photos

Side of the Tyringham Town Hall building. There is a very faint white painted line on the pavement. A blue sign that reads Handicap Parking Only with no International Symbol of Accessibility is posted on the side of the building above the parking space.

| Polling Place, Municipality | Area(s) of Concern | Issue(s) Identified | Law(s) /Regulation(s) | Suggestion(s) |
|---|---|---|---|---|
| | | 1.2 The accessible parking spaces were not marked clearly with above-ground signage (the International Symbol of Accessibility is missing from the above-ground signage). (See <a href="#">Tyringham Town Hall Photos</a> ) | 950 CMR 51.02(2) | 1.2 Each accessible parking space/pair of accessible spaces should be identified by a sign between five and eight feet above the ground containing the International Symbol of Accessibility. Van accessible parking spaces should be identified by signage containing the words "Van Accessible." |

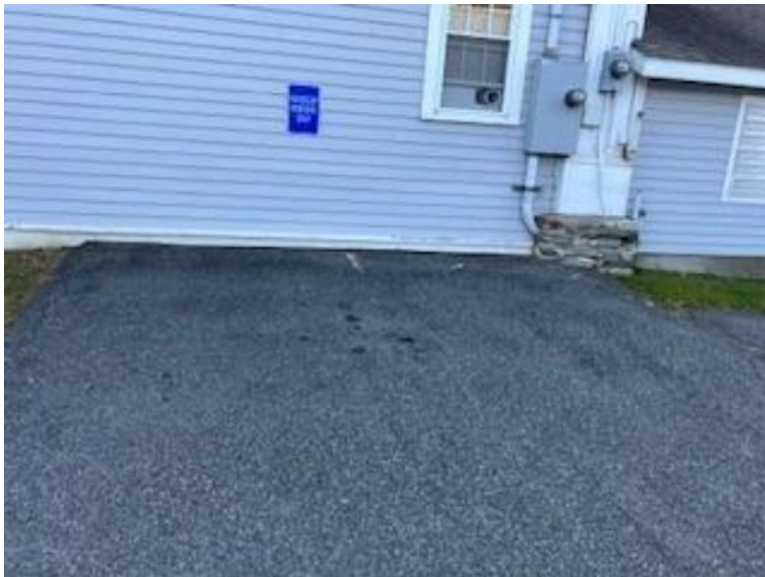
Further view of the side of the Tyringham Town Hall and part of the accessible parking area. The pavement has one very faint line marking the accessible parking space. There is a blue sign on the building that reads Handicap Parking Only with no symbol.

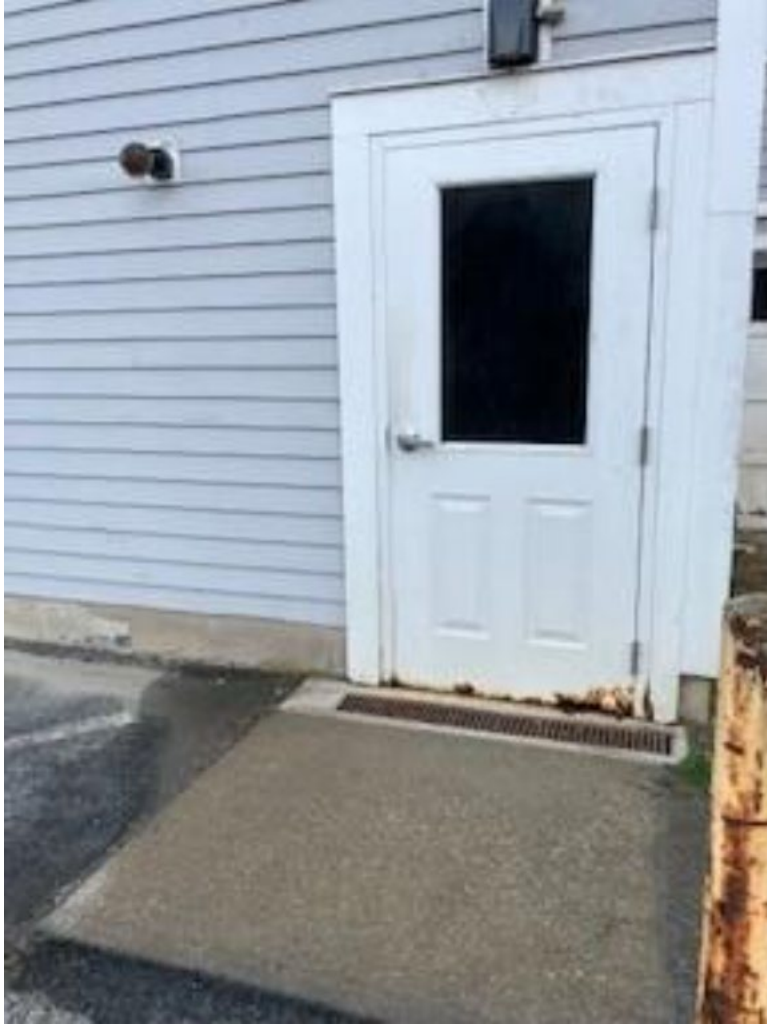
The rear exterior entrance to Tyringham Town Hall. There is a cement landing in front of the door. The threshold to enter the door is over 1 inch above the ground.

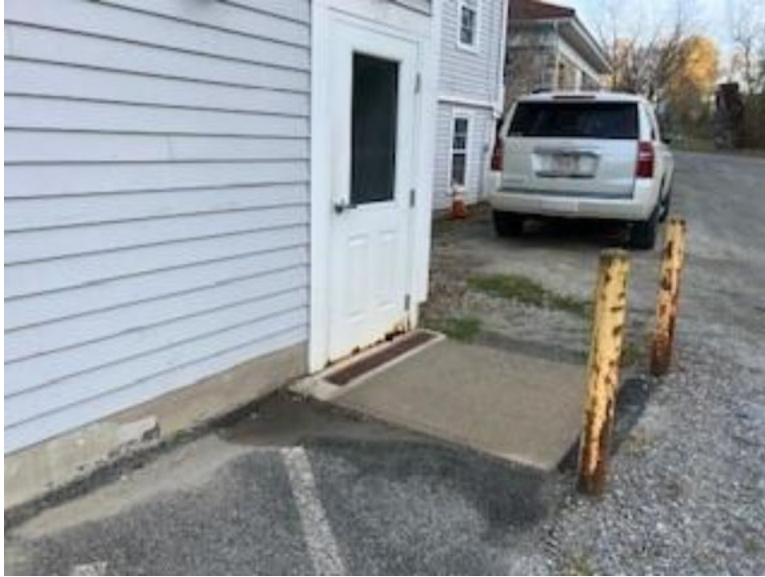
Side view of the exterior entrance to the Tyringham Town Hall. The threshold to enter is over one inch above the ground.

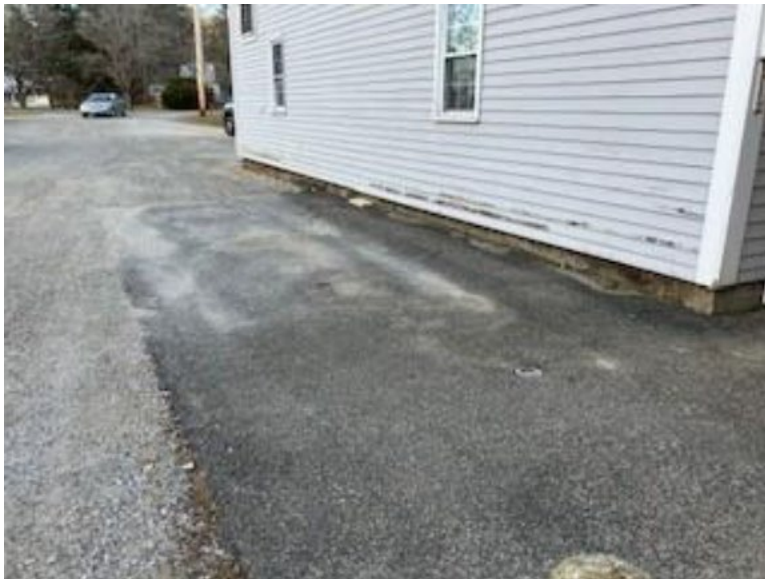
Side of the Tyringham Town Hall and part of the parking lot. The parking lot is partially paved on the perimeter of the building, while the rest of the parking lot is gravel. There are some uneven areas in the parking lot.

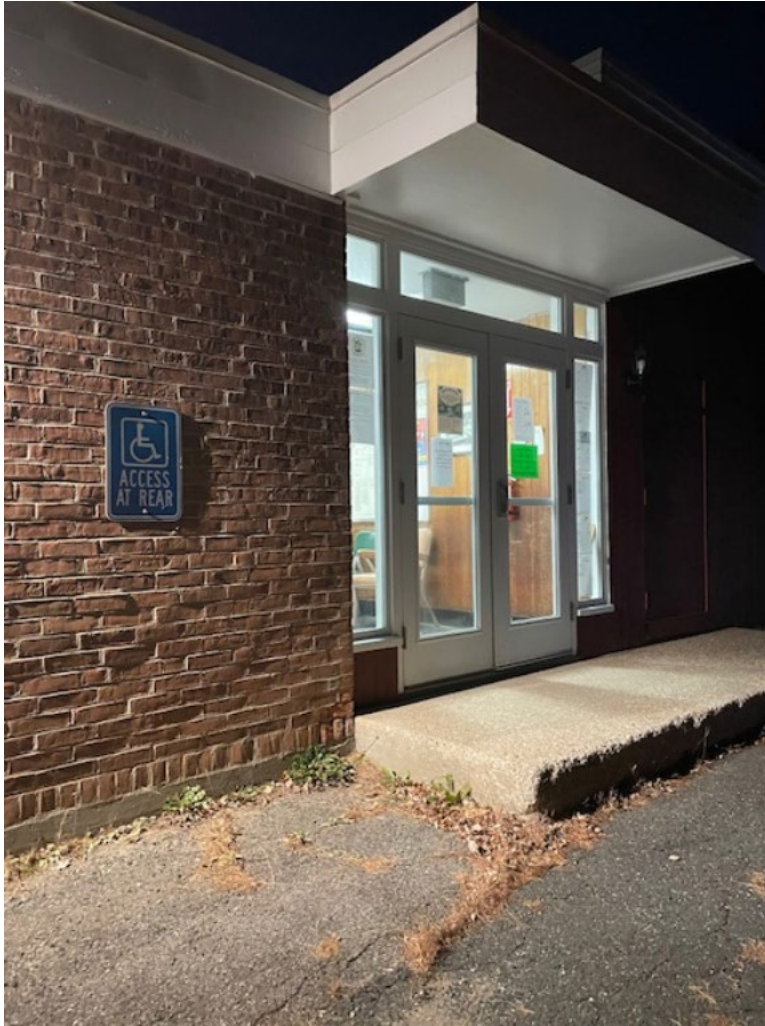
Main entrance to the Washington Town Hall in the evening. There is a blue sign with the international symbol of accessibility reading Access at Rear. There is a cement step and landing leading to the entrance doors.

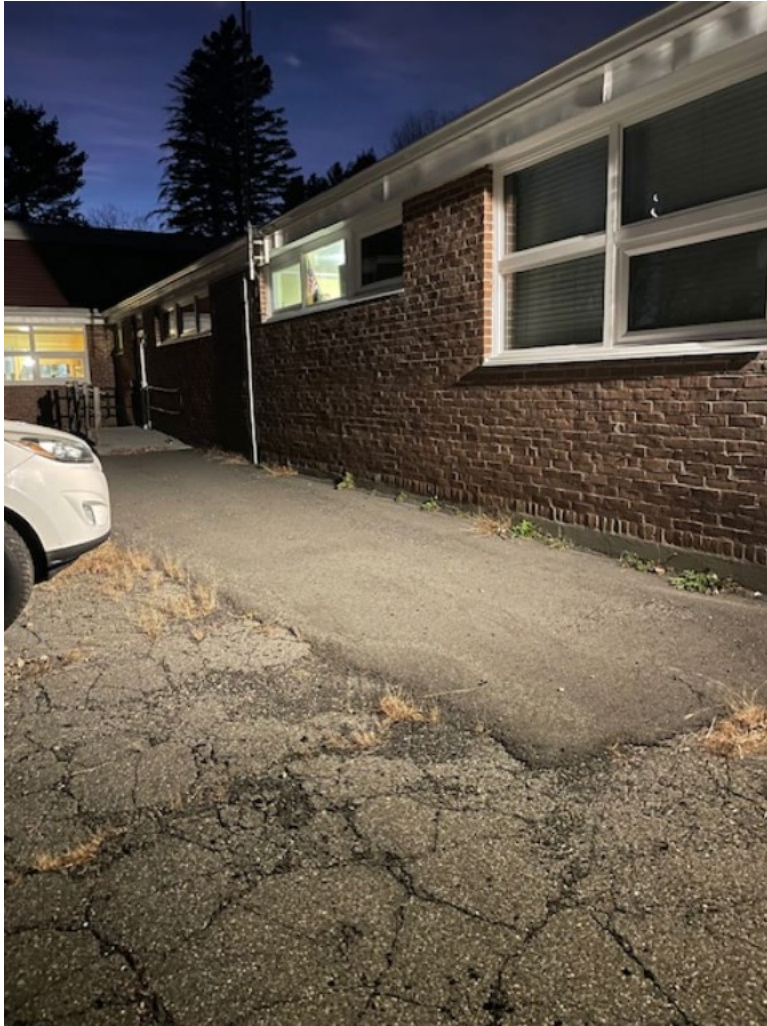
The path of travel at the back of Washington Town Hall leading to the accessible entrance. The area has broken and patched pavement.

| Polling Place, Municipality | Area(s) of Concern | Issue(s) Identified | Law(s) /Regulation(s) | Suggestion(s) |
|---|---|---|---|---|
| Washington Town Hall, Washington | 1. Exterior | 1.1 The pavement in the path of travel/back parking lot is very cracked, creating abrupt changes in level greater than ½ inch. (See <a href="#">Washington Town Hall Photos</a> ) | 950 CMR 51.02(1) | 1.1 Paths of travel should be common, continuous surfaces uninterrupted by abrupt changes in level greater than ½ inch. |

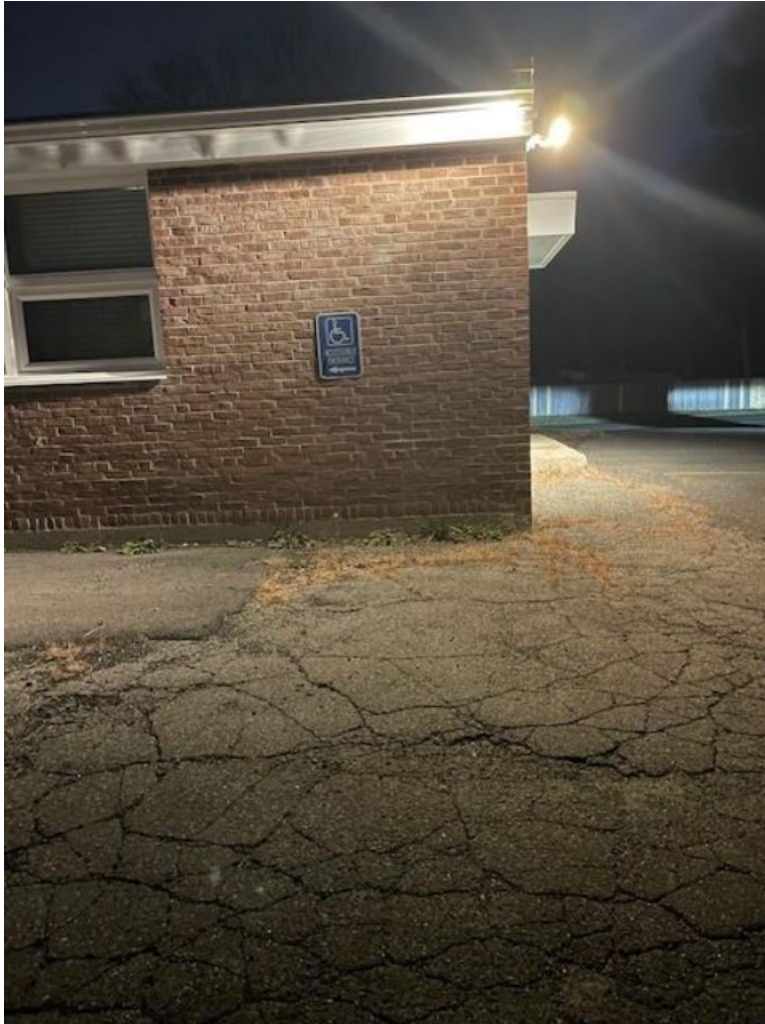
The back of Washington Town Hall during the evening. The area around the building has broken and patched pavement. A sign posted on the building directs voters to the accessible entrance.

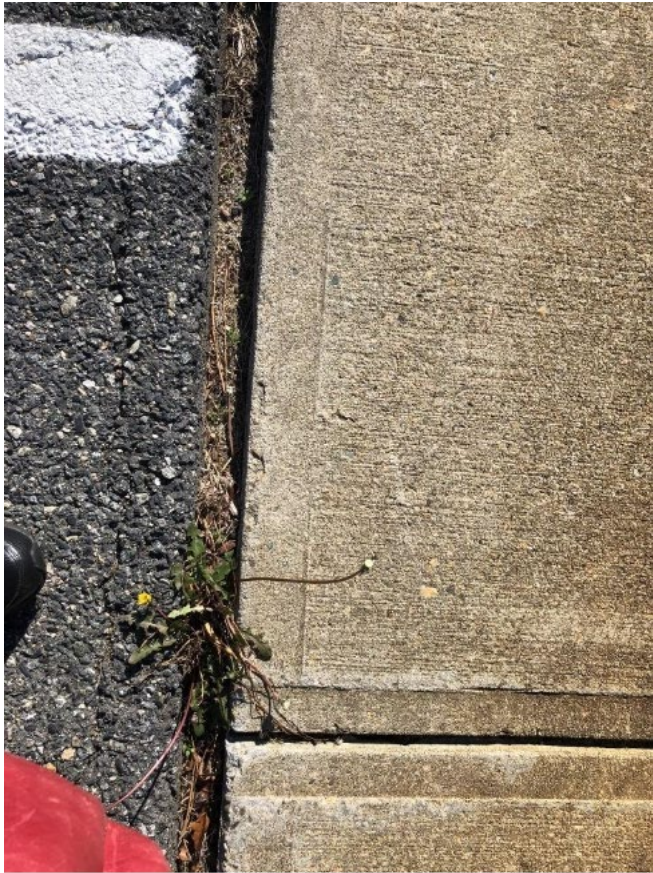
### Mashpee Senior Center Photos

Gap between sidewalk and pavement at the Mashpee Senior Center.

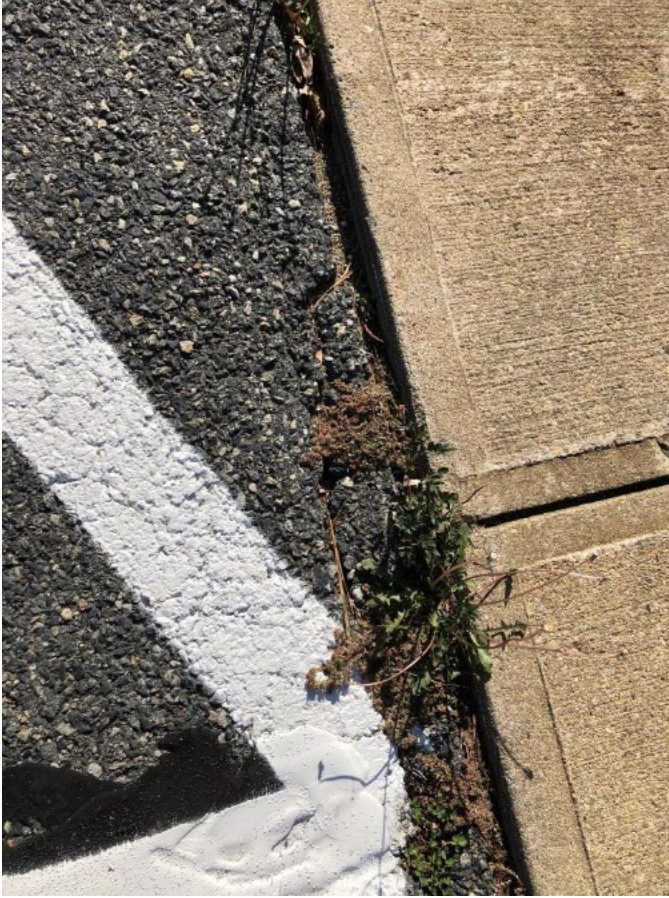
Gap between sidewalk and pavement at the Mashpee Senior Center.

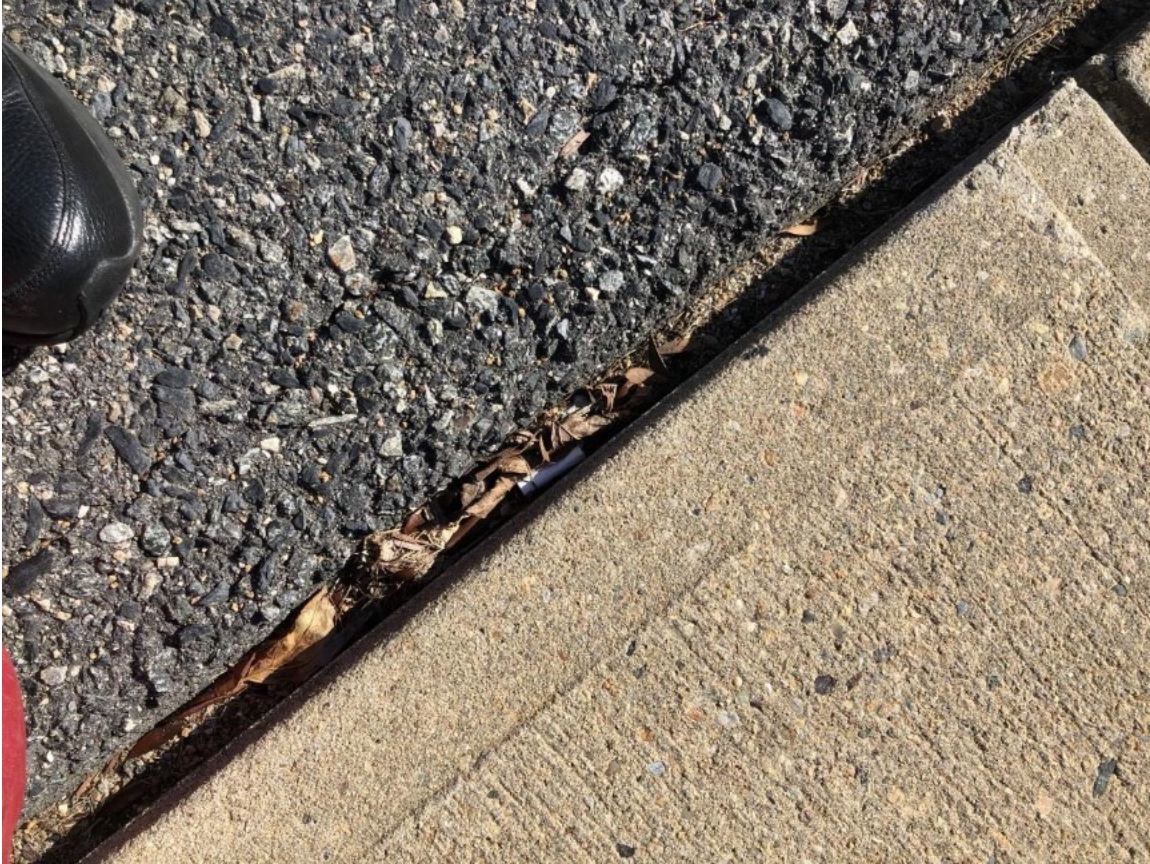
Gap between sidewalk and pavement at the Mashpee Senior Center.

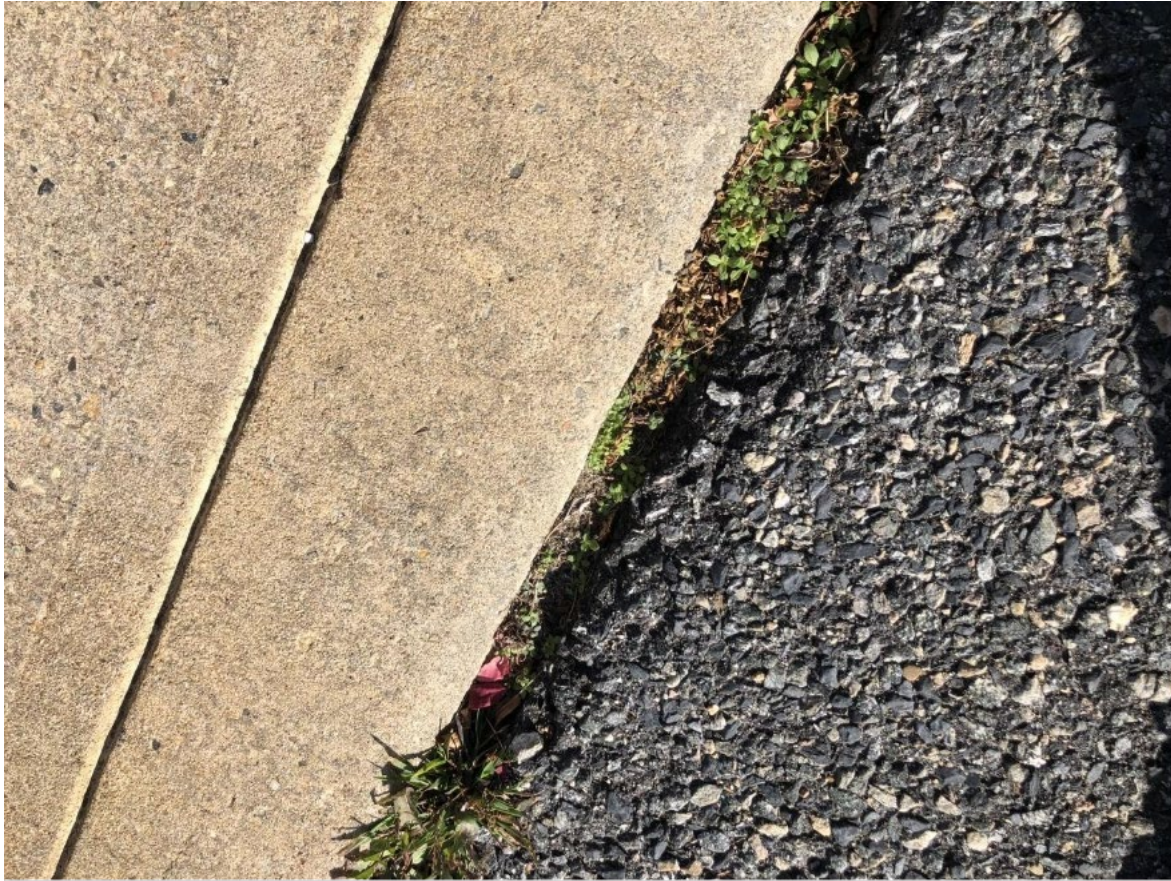
Gap between sidewalk and pavement at the Mashpee Senior Center.

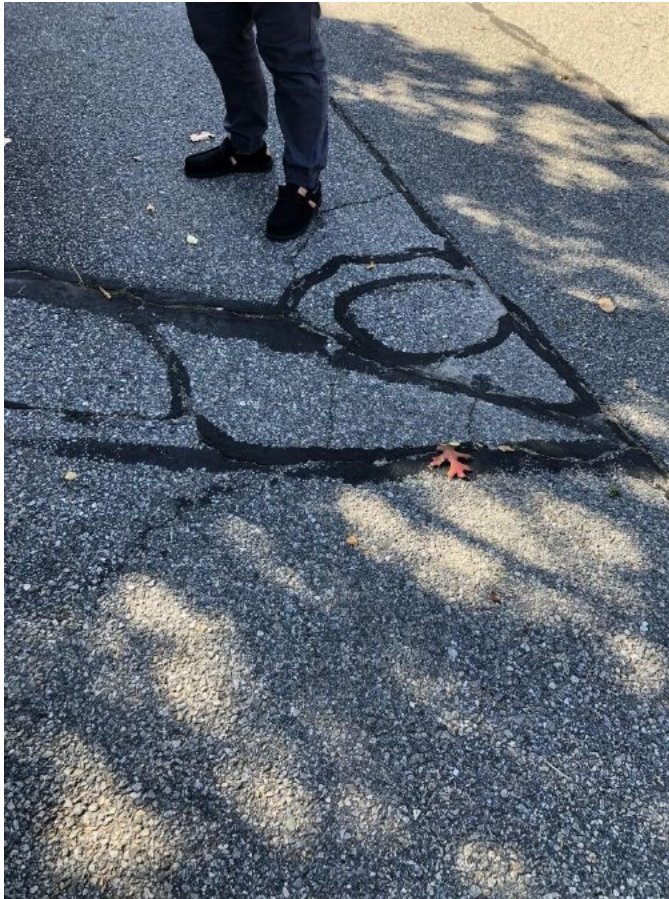
## Mashpee Town Hall Photos

Pavement near the Mashpee Town Hall. There are some cracks and divets in the pavement and areas where the pavement has been patched.

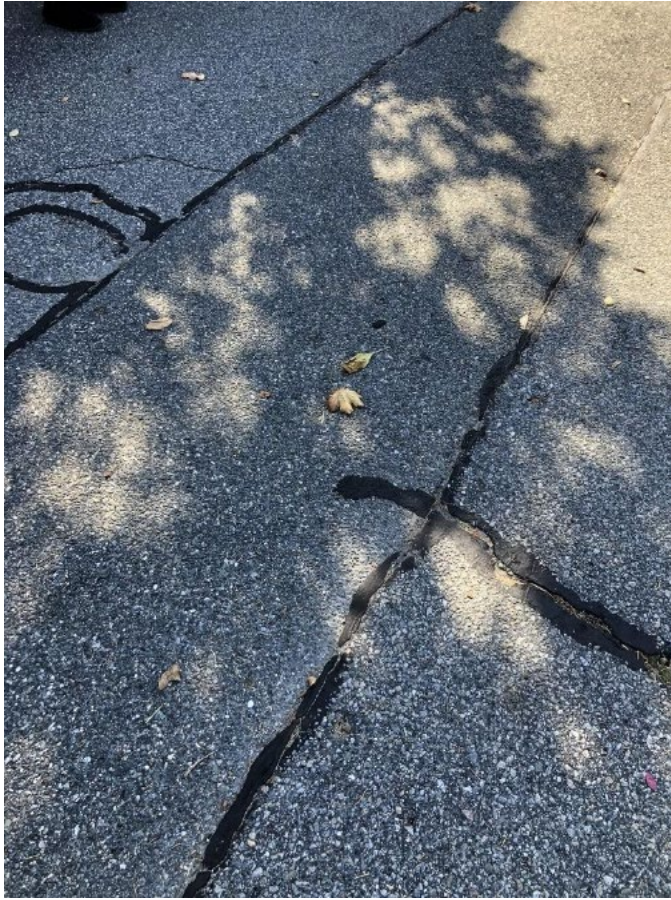
Pavement near the Mashpee Town Hall. There appears to be a slight incline. The pavement has some cracks and patching.

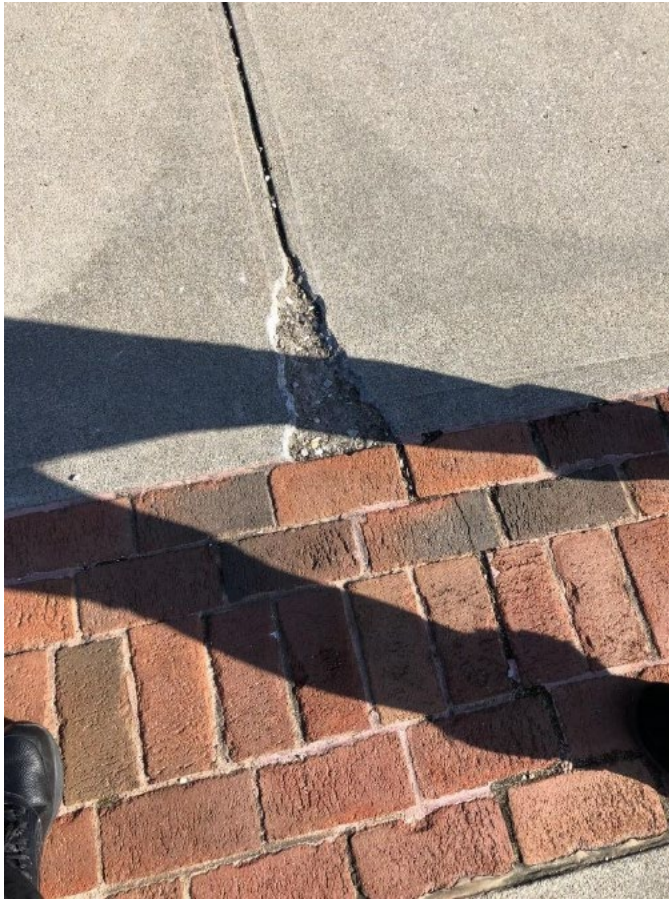
Cement sidewalk lined with laid bricks at the Corpus Christi Parish Hall. There is a crack where the slabs of cement meet which is roughly less than a foot long and a few inches wide, greater than  $\frac{1}{2}$  inch deep.

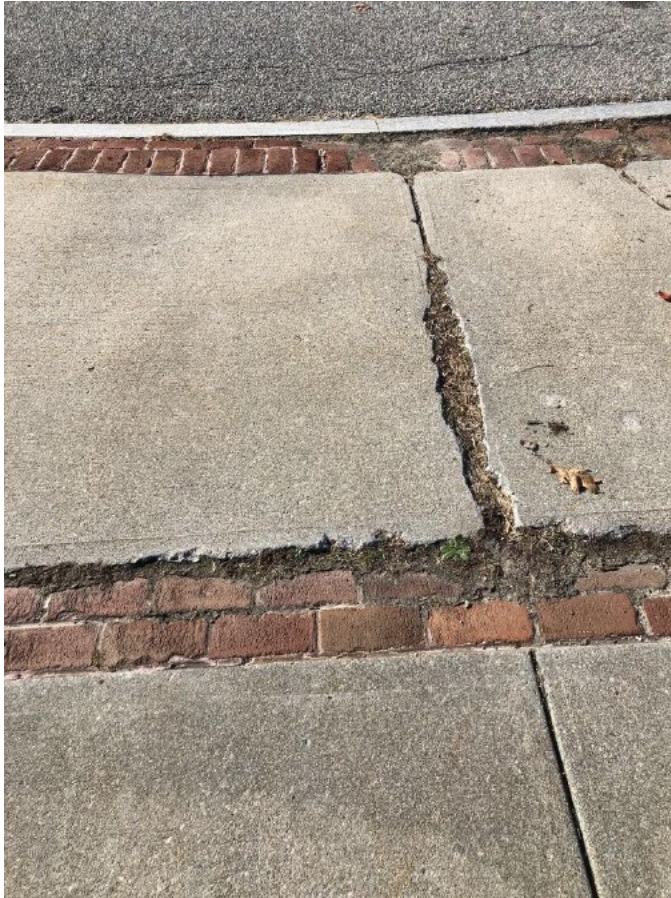
The path of travel at Corpus Christi Parish Hall. There is a relatively flat curb next to the paved parking lot. Bricks line the cement sidewalk. There are cracks deeper than  $\frac{1}{2}$  inch in the cement sidewalk and bricks.

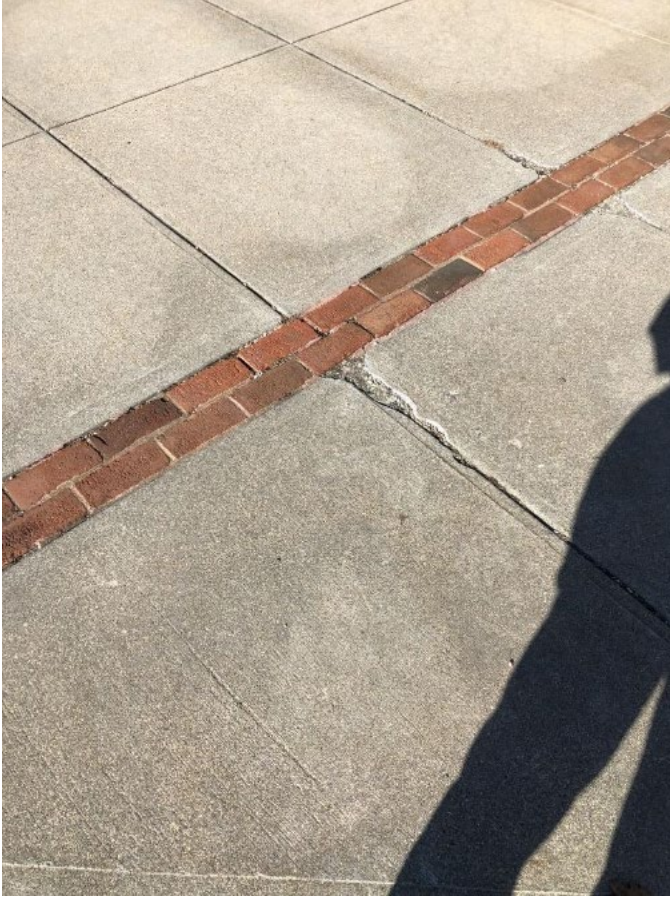
The path of travel to the Corpus Christi Parish Hall. There is a crack in the cement walkway.

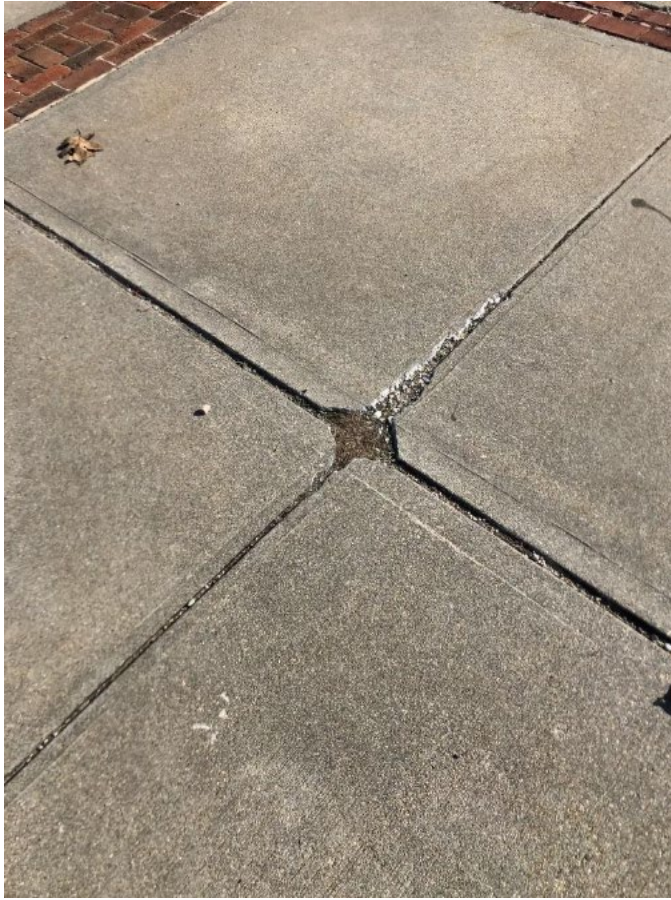
The path of travel to the Corpus Christi Parish Hall. The area where four slabs of cement meet has a crack interrupting the path of travel.

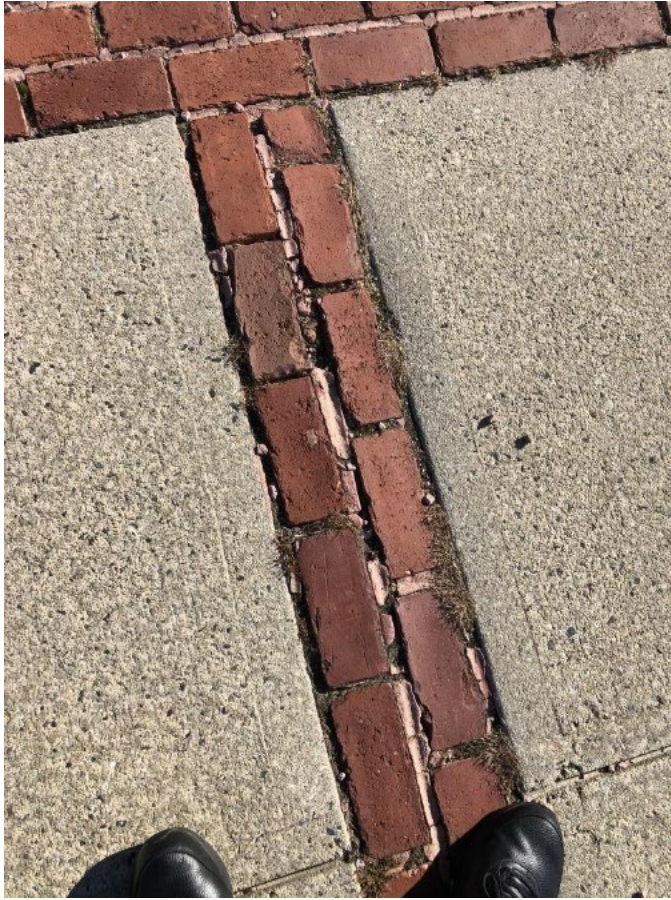
A closer view of the bricks lining a cement walkway to Corpus Christi Parish. The edges of the bricks have been broken in some areas.

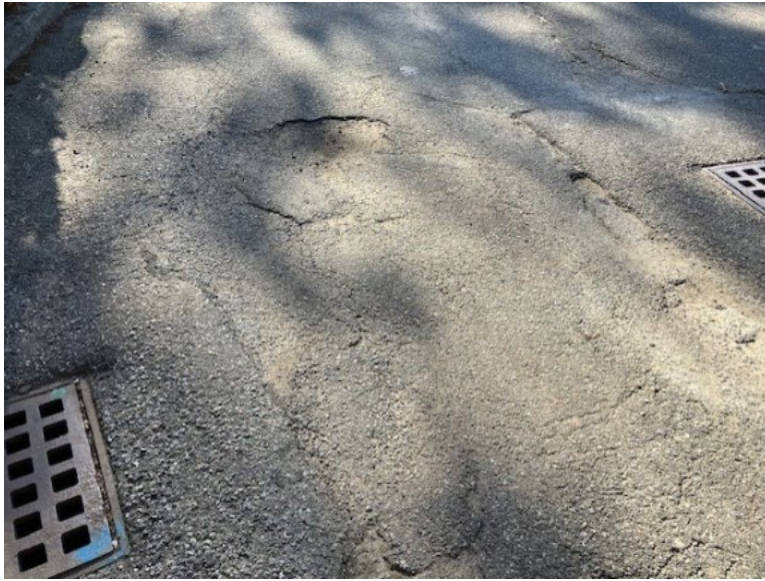
Parking lot leading to the Arlington Town Hall. Cracks and holes in the pavement are greater than ½ inch deep.

| Polling Place, Municipality | Area(s) of Concern | Issue(s) Identified | Law(s) /Regulation(s) | Suggestion(s) |
|---|---|---|---|---|
| Arlington Town Hall, Arlington Precincts 8 – 10 | 1. Exterior Path of Travel | 1.1 The exterior path of travel is interrupted by abrupt changes in level greater than ½ inch. (Cracks in pavement) (See <a href="#">Arlington Town Hall Photos</a> ) | 950 CMR 51.02 (1) | 1.1 The exterior path of travel should be clear, unobstructed, reasonably lit, and have a continuous surface without abrupt changes in level more than ½ inch. |

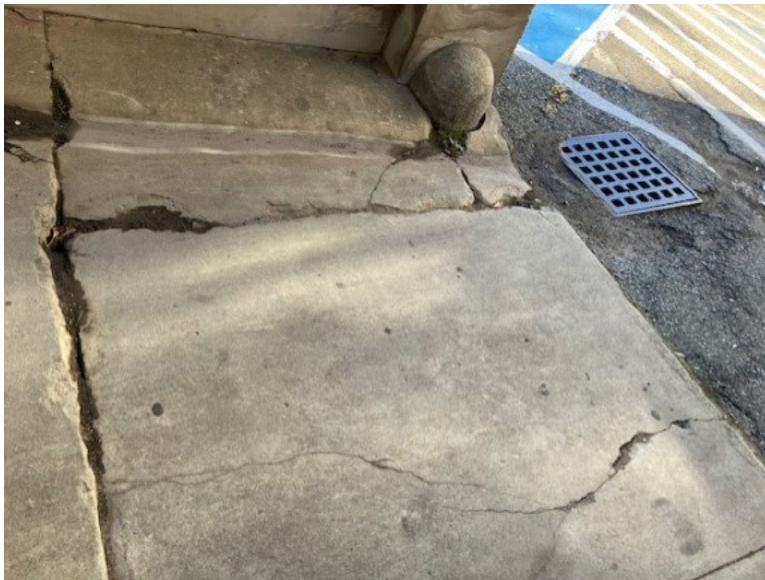
Cement walkway leading to Arlington Town Hall. The cement is very cracked and broken in several areas, leading to abrupt changes in level greater than ½ inch.

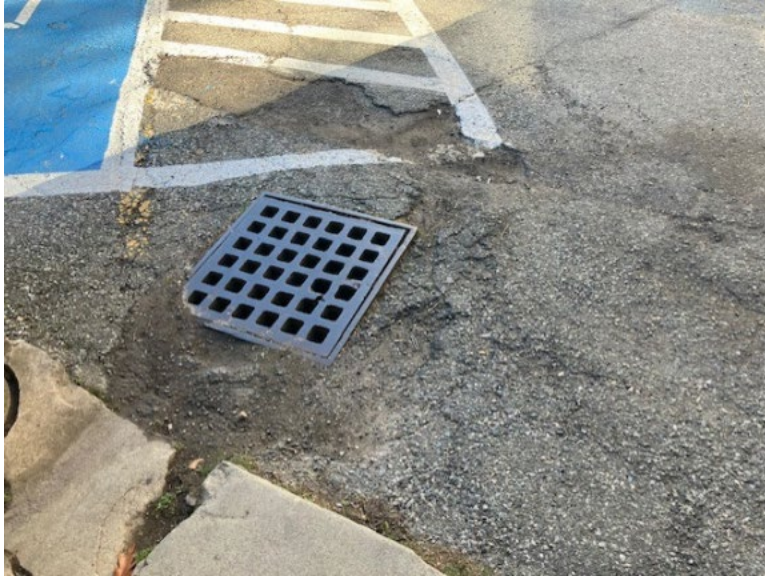
The path of travel in front of an accessible parking space access aisle. The pavement in the access aisle has cracks and depressions greater than ½ inch. A sewer grate is directly in front of the access aisle and leads to a cement walkway which has large cracks.

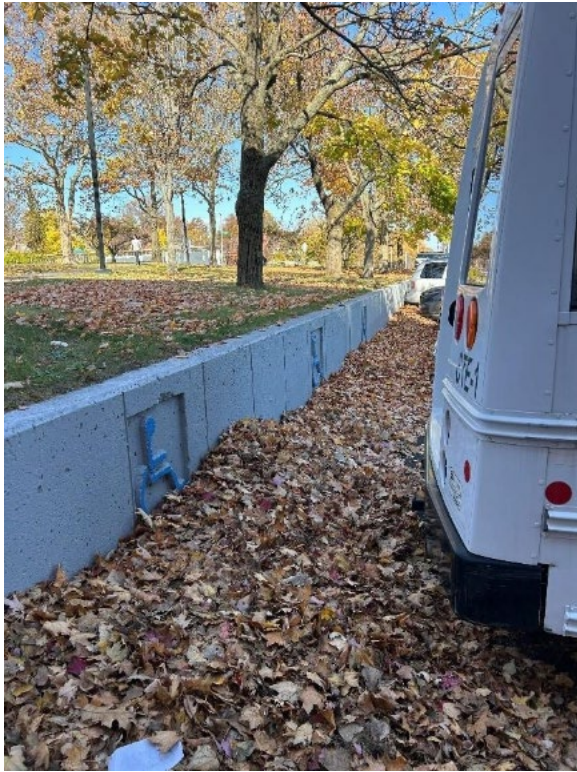
Several parking spaces in the Boston East English High School. There is a cement wall barrier about three feet tall with International Symbols of Accessibility engraved on a row of parking spaces. The pavement and paint are not visible due to a thick layer of leaves covering the ground.

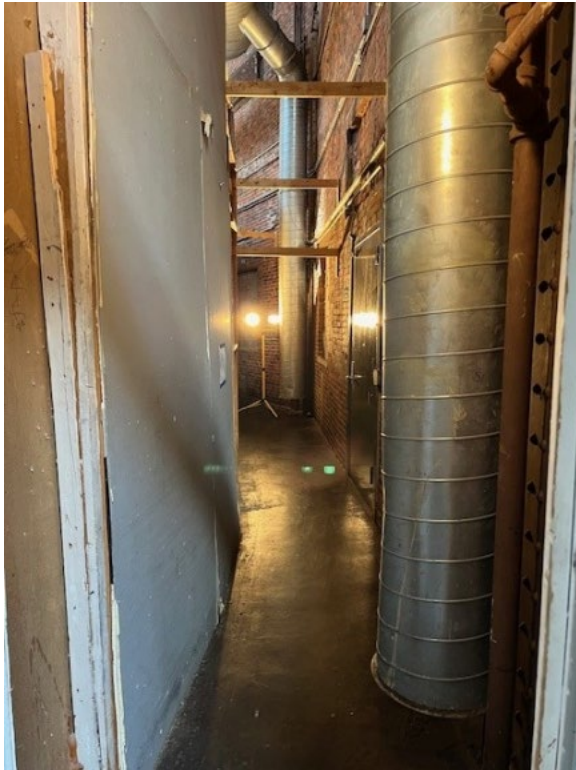
## Cyclorama Boston Photo

An unfinished hallway with floodlights shining in the hallway. A large metal pipe appears to obstruct the path of travel.

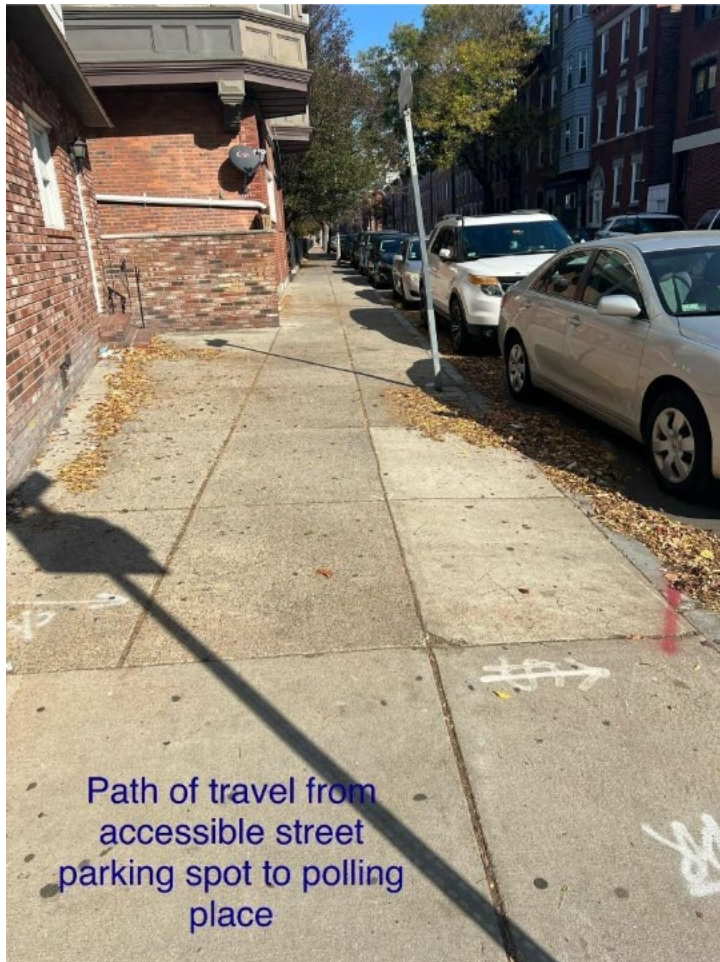
## Donald McKay School Boston Photos

Sidewalk leading to Donald McKay school, with cars parked along the side of the sidewalk. There are some uneven slabs in the sidewalk. The surveyor's note reads, Path of travel from accessible street parking spot to polling place.

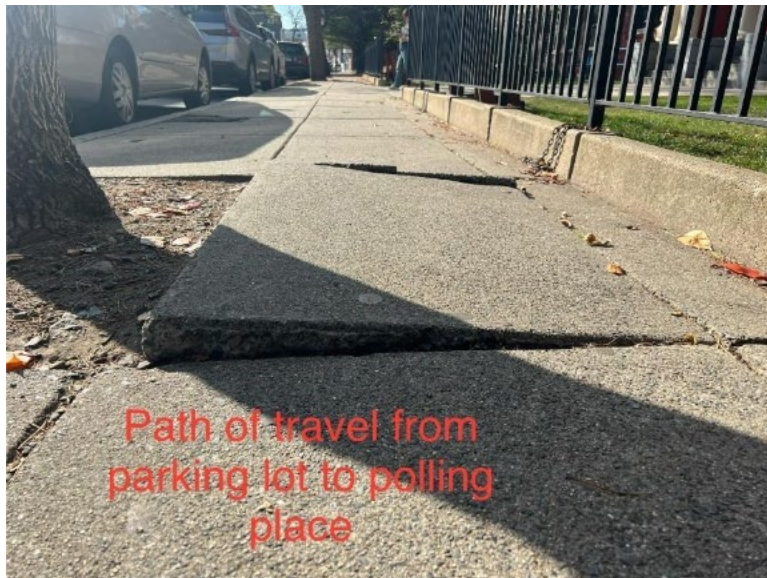
Closeup view of the sidewalk leading to Donald McKay School. There are slabs coming loose and making uneven surfaces in the path of travel. The surveyor's note reads, Path of travel from parking lot to polling place.

| Polling Place, Municipality | Area(s) of Concern | Issue(s) Identified | Law(s) /Regulation(s) | Suggestion(s) |
|---|---|---|---|---|
| Donald McKay School, Boston Ward 1 Precinct 2 | 1. Exterior Path of Travel | 1.1 The exterior path of travel was interrupted by abrupt changes in level greater than ½ inch (due to broken pavement/uneven sidewalks). (See <a href="#">Donald McKay School Boston Photos</a> ) | 950 CMR 51.02(1) | 1.1 The path of travel should be a level surface uninterrupted by abrupt changes in level greater than ½ inch. |

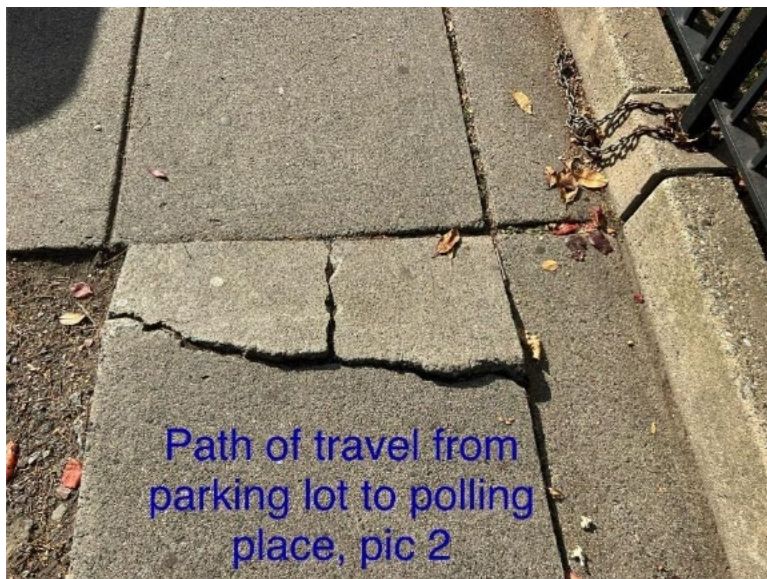
Closeup view of the sidewalk leading to Donald McKay School. There are concrete slabs lifting from the ground and making uneven surfaces in the path of travel. The concrete slabs are cracked in several places. The path of travel appears narrow where there is a tree planted to the left and curb to the right. The surveyor's note reads, Path of travel from parking lot to polling place, pic 2.

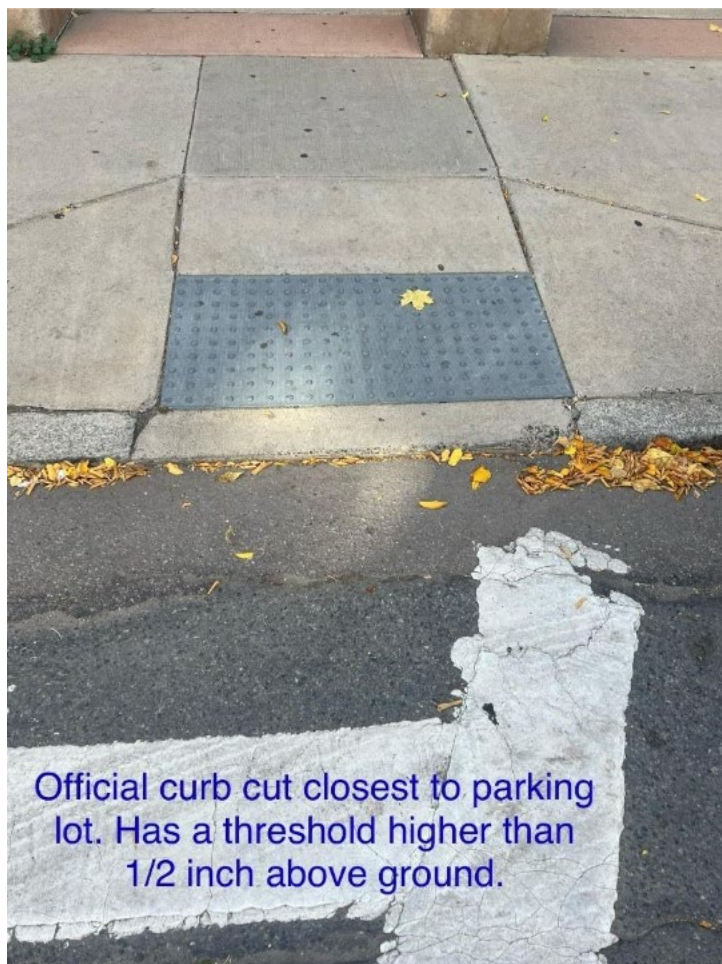
A crosswalk leads to a sidewalk and curb cut with grey tactile paving in the path of travel to the Donald McKay School. There are cracks in the pavement leading up to the curb cut and raised pavement greater than  $\frac{1}{2}$  inch. Surveyor's note reads, Official curb cut closest to parking lot. Has a threshold higher than  $\frac{1}{2}$  inch above ground.

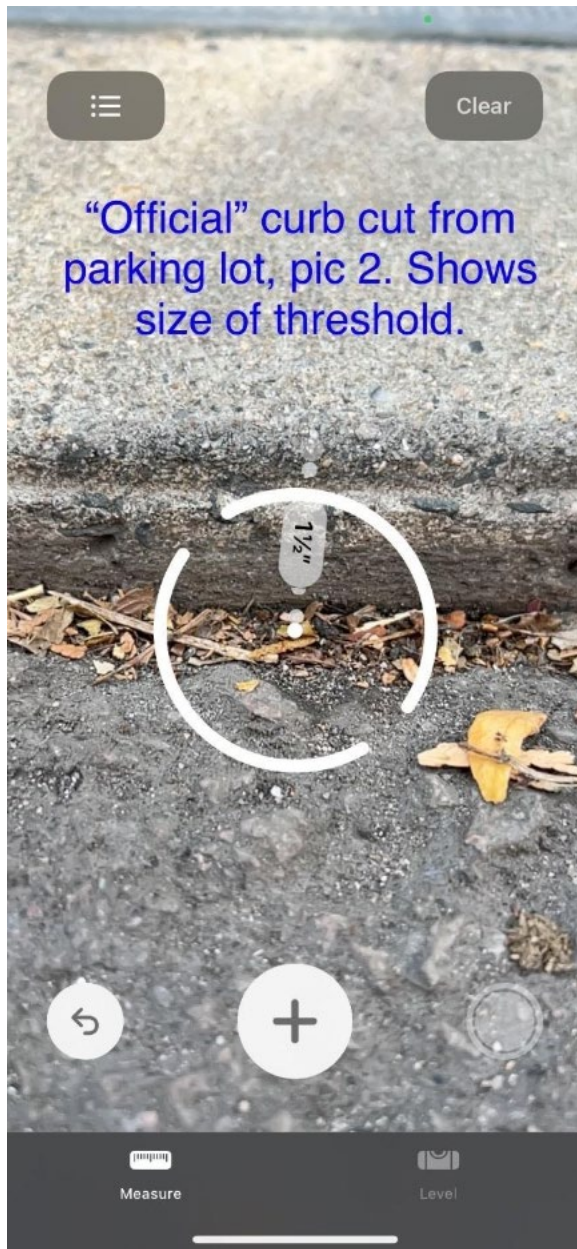
Screenshot closeup of the threshold leading from the parking lot to curb cut using the iPhone measure feature. The measurement shows that there is a threshold of 1.5 inches leading to the curb cut. The surveyor's note reads, "Official" curb cut from parking lot, pic 2. Shows size of threshold.
