# Voting Accessibility in Massachusetts: 2024 General Election

Report by  
Disability  
Law  
Center,  
Inc.

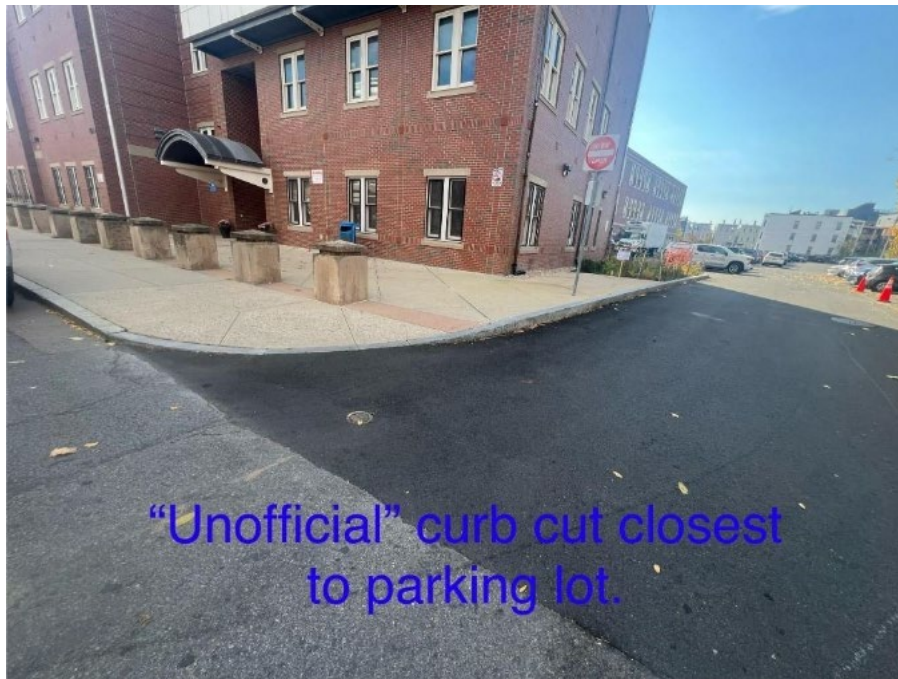
The front of Donald McKay school, with a section of the parking lot visible in the distance behind the building. There is a curb cut leading to the front of the building from the street. Cement barriers are placed along the perimeter of the building. Surveyor's note: "Unofficial" curb cut closest to the parking lot.

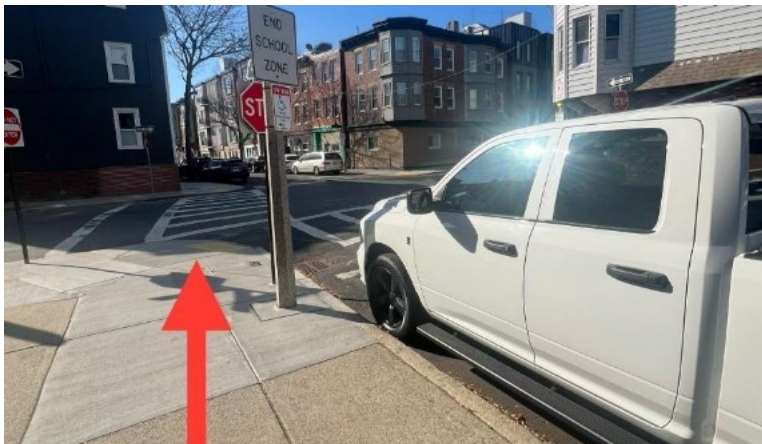
On-street accessible parking space near a four-way intersection in front of Donald McKay School. There is a curb cut where two crosswalks meet to the upper left of the accessible parking space, but no access aisle leading from the parking space to the curb cut.

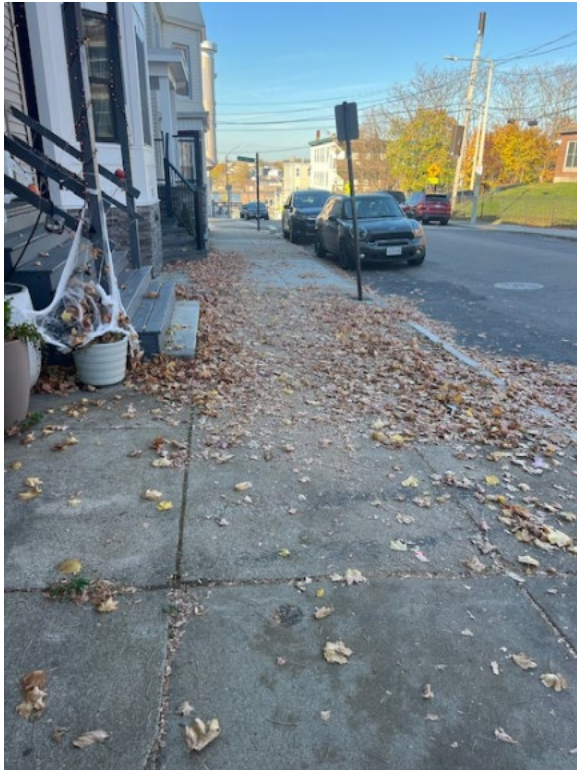
## East Boston High School Photos

Uneven sidewalk in the path of travel to East Boston High School.

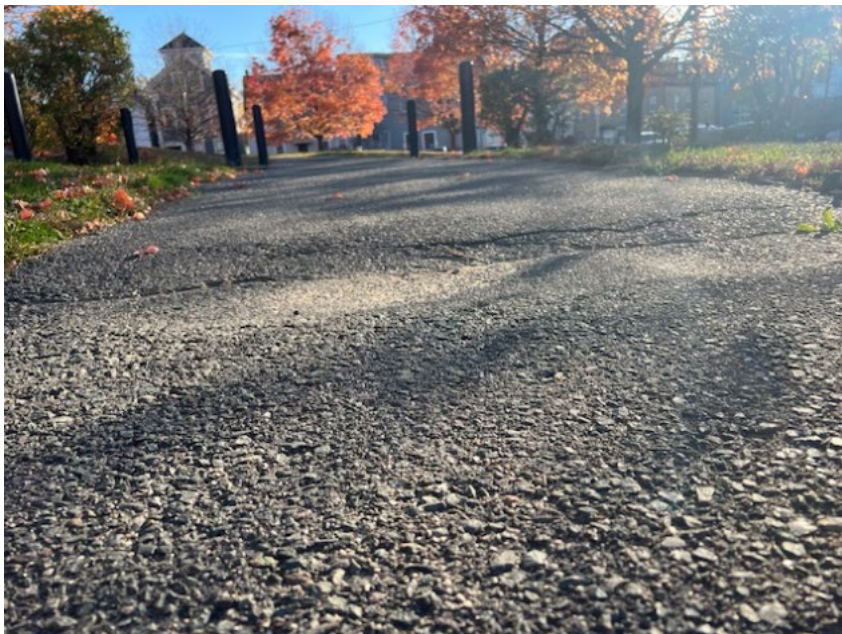
A paved walkway leading to the East Boston High School polling site. There are some cracks and changes in level in the pavement.

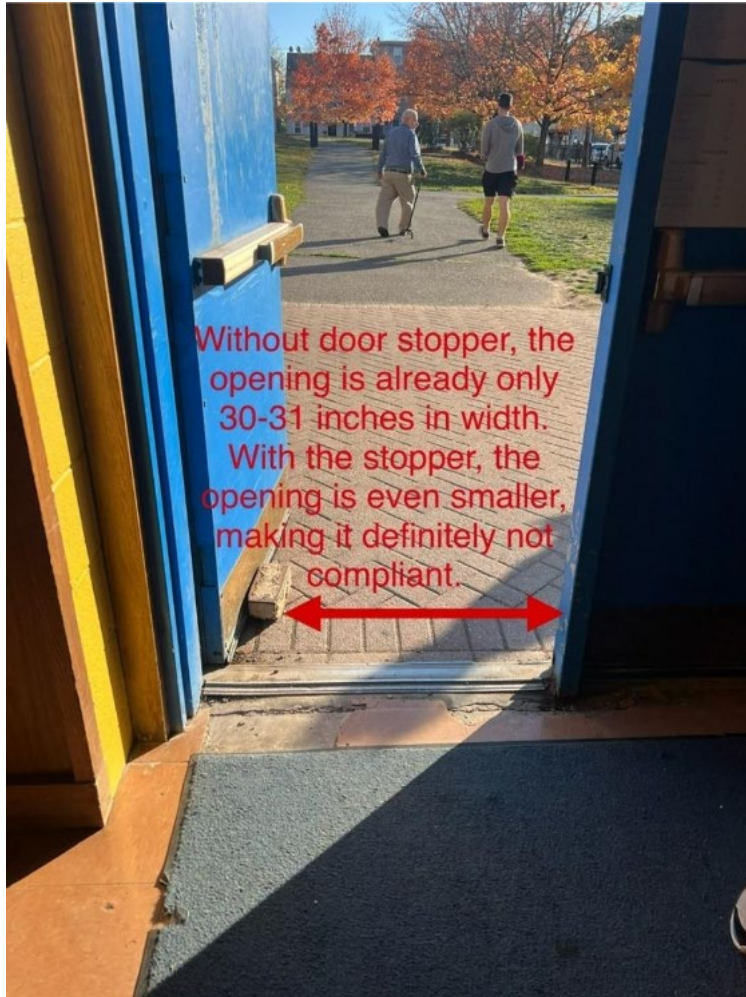
The doorway leading into East Boston High School. The door is held open with a block which partially blocks the doorway. The surveyor noted: Without a door stopper, the opening is already only 30-31 inches in width. With the stopper, the opening is even smaller, making it definitely not compliant.

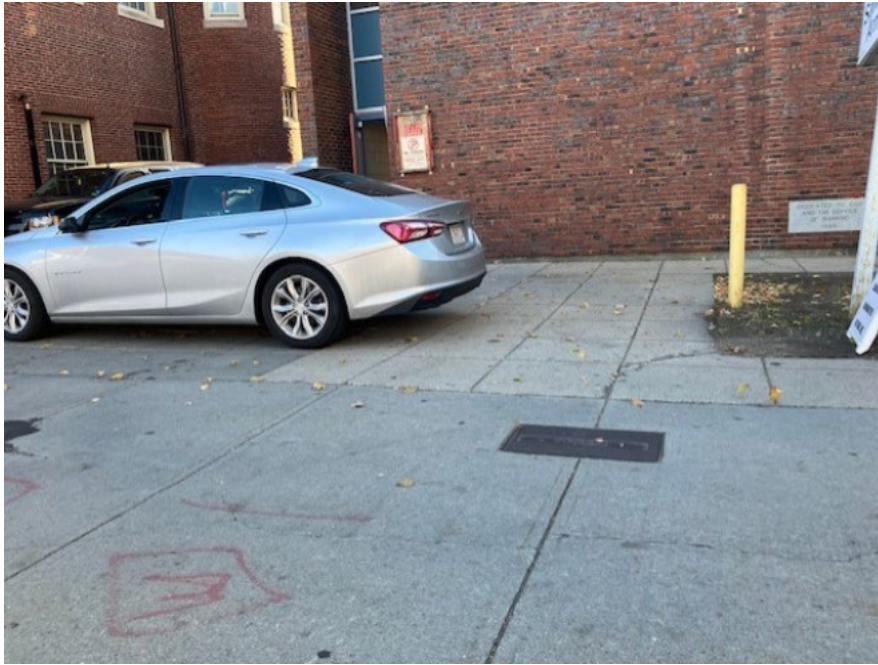
## Salvation Army Cambridge Photos

Parking lot behind the Salvation Army in Cambridge. No HP signs or striping are visible.

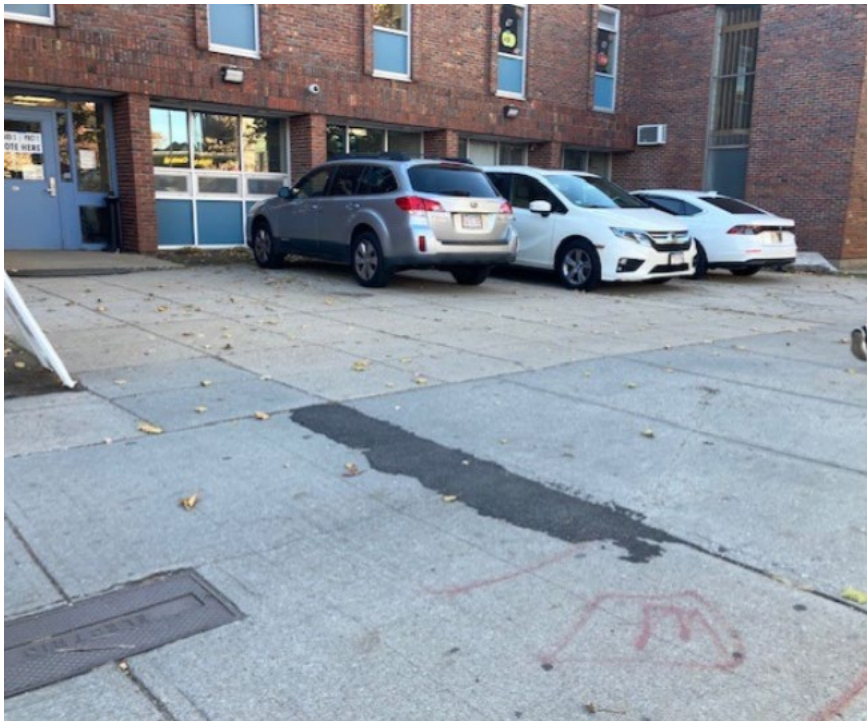
Parking lot behind the Salvation Army in Cambridge. There are several cars parked along the building and some patched pavement. No HP signs or striping are visible.

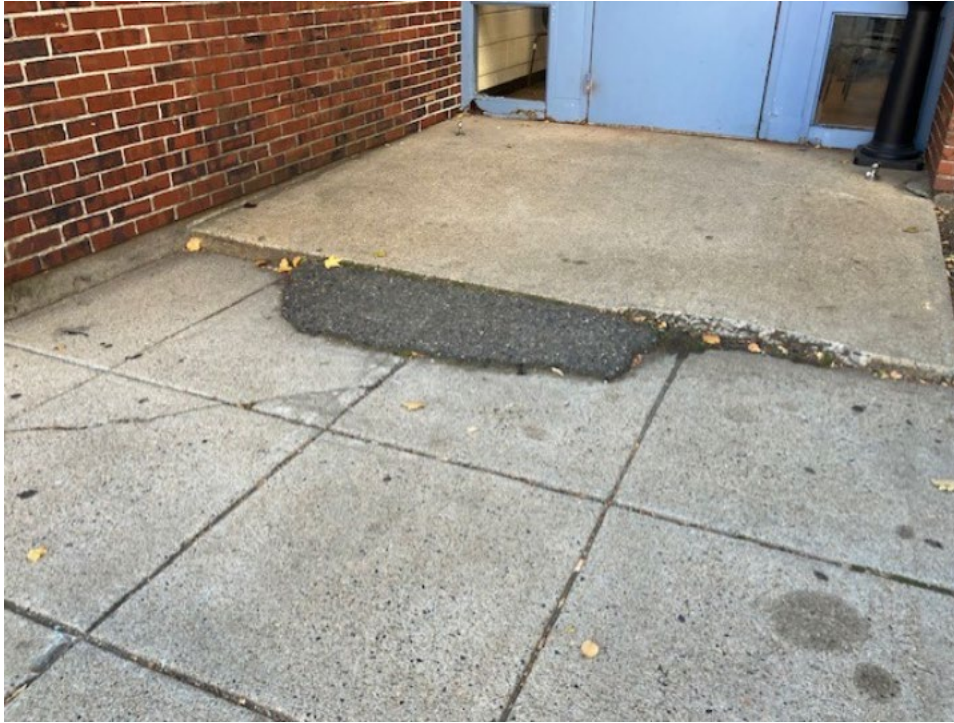
Concrete area outside of the entrance to the Salvation Army polling site. The space between the landing and the walkway has been patched unevenly with pavement, lacking a compliant ramp.

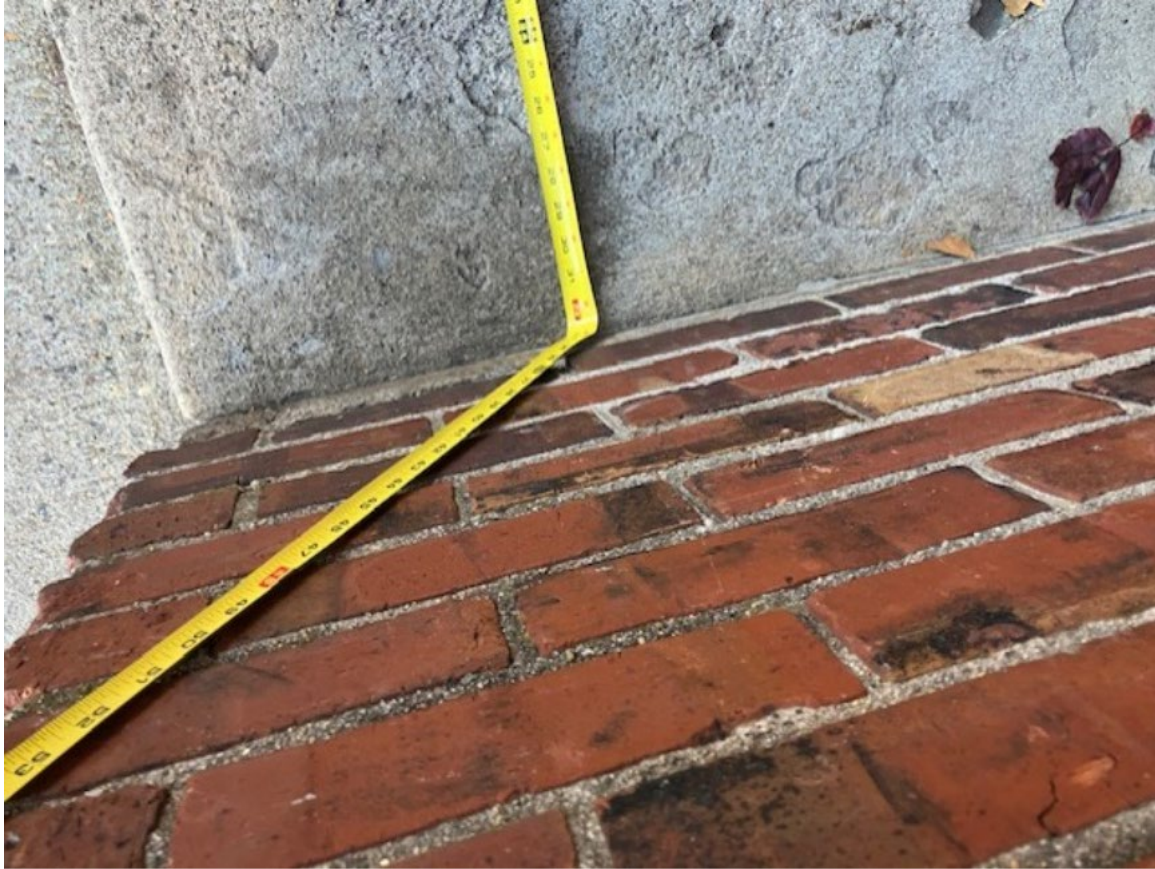
A tape measure measures the clear space between the brick wall and entrance door to the Salvation Army polling site. The tape measure shows that there is a space between the wall and door measuring 32 inches.

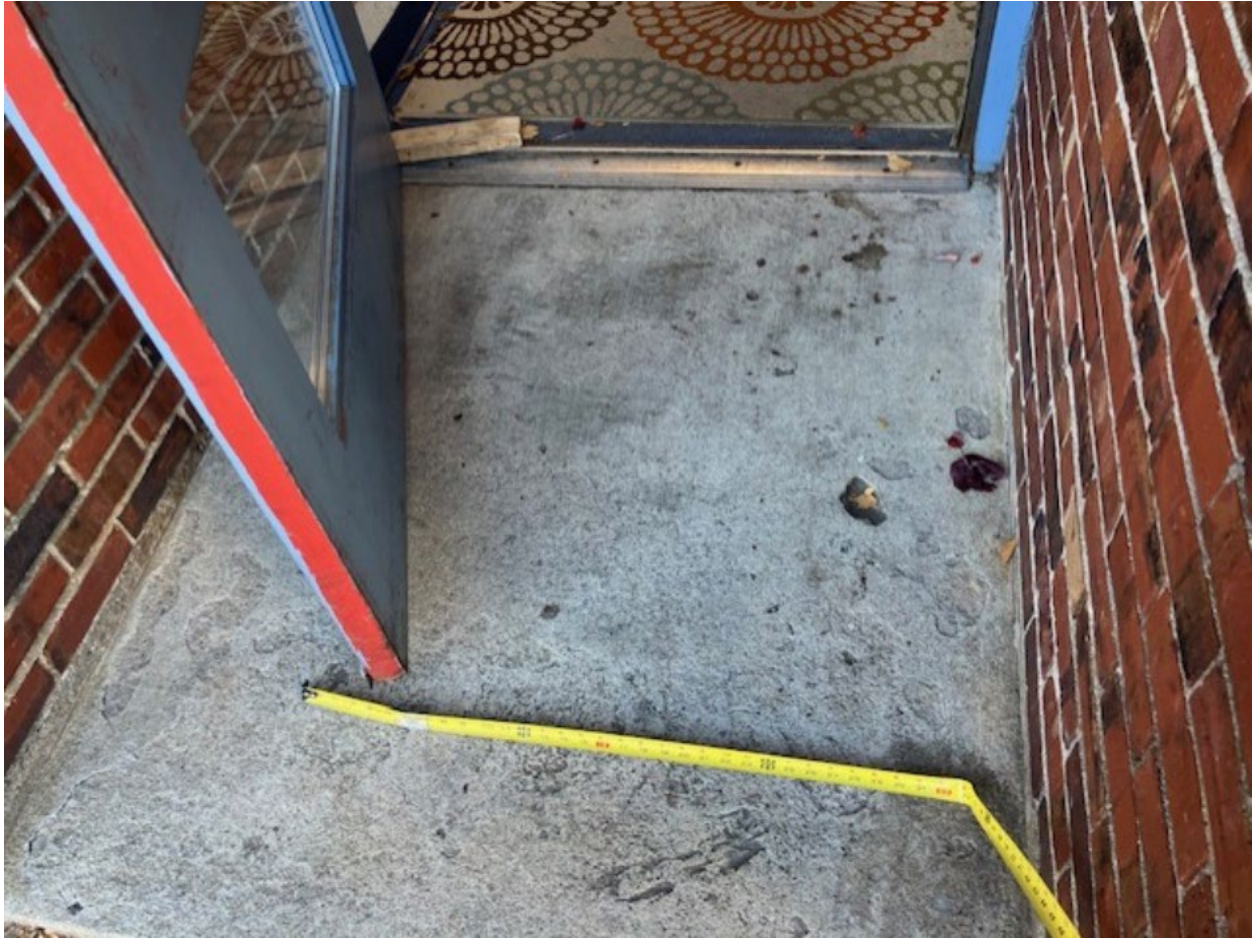
A door is being propped open with a wooden block to the inside of the Salvation Army polling place entrance. The clear space between the door and brick wall measures under 32 inches. The wooden block propping the door open obstructs the doorway.

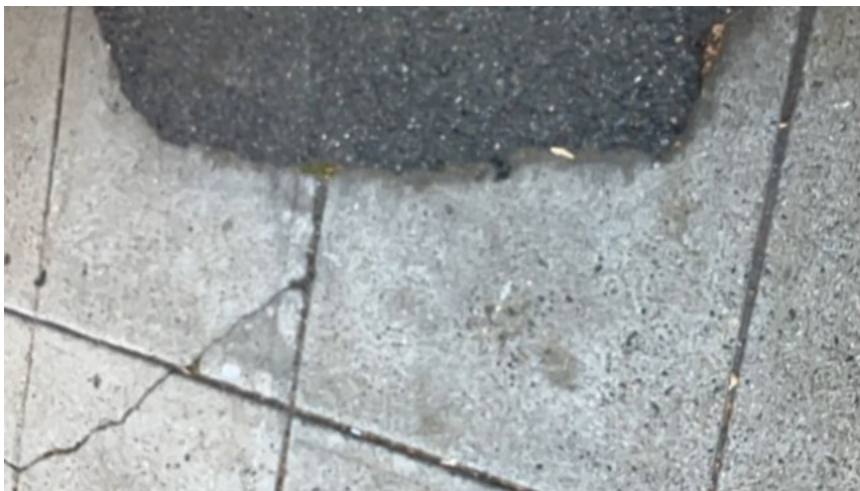
Closeup of the unlevel patch of pavement in front of the cement landing.

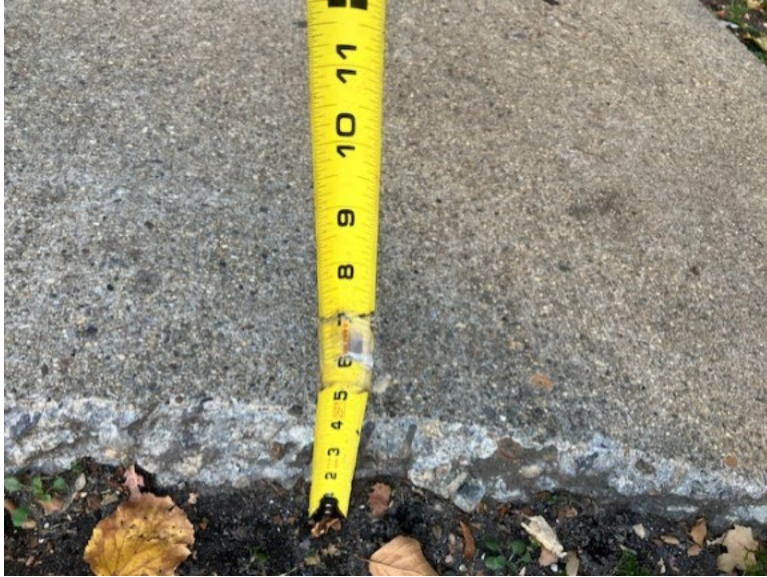
A cement landing with a measuring tape in front of it, showing that the step measures four to five inches.

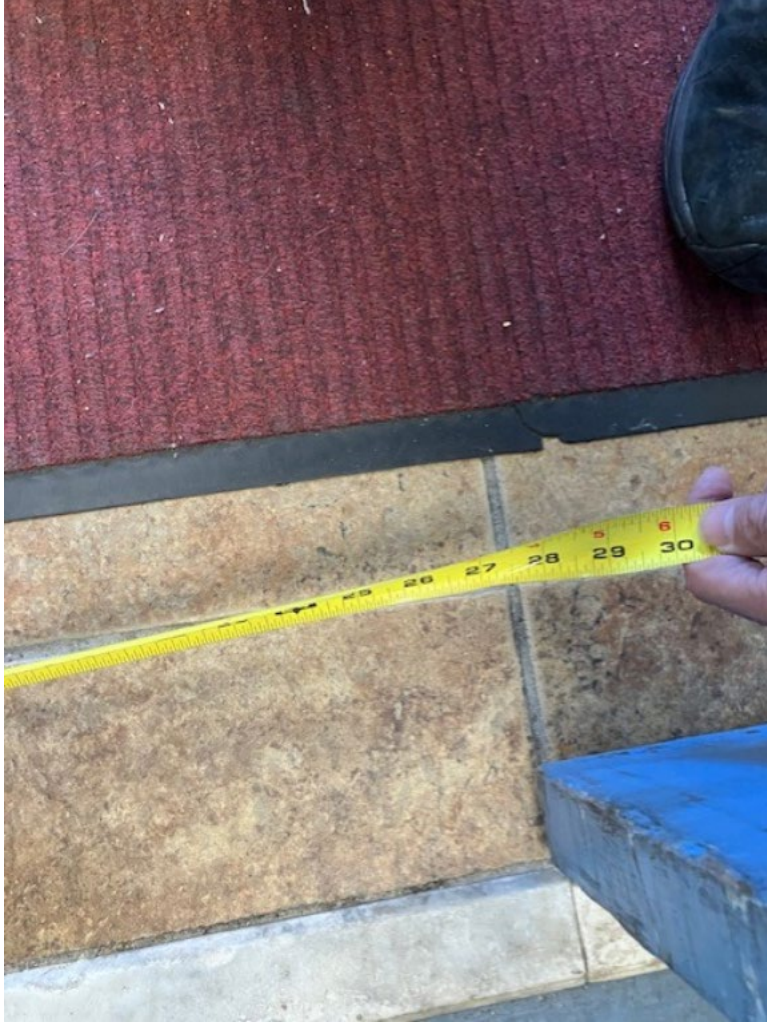
The front entry to the Salvation Army is being measured. The clear space between the doorway measures about 27 inches.

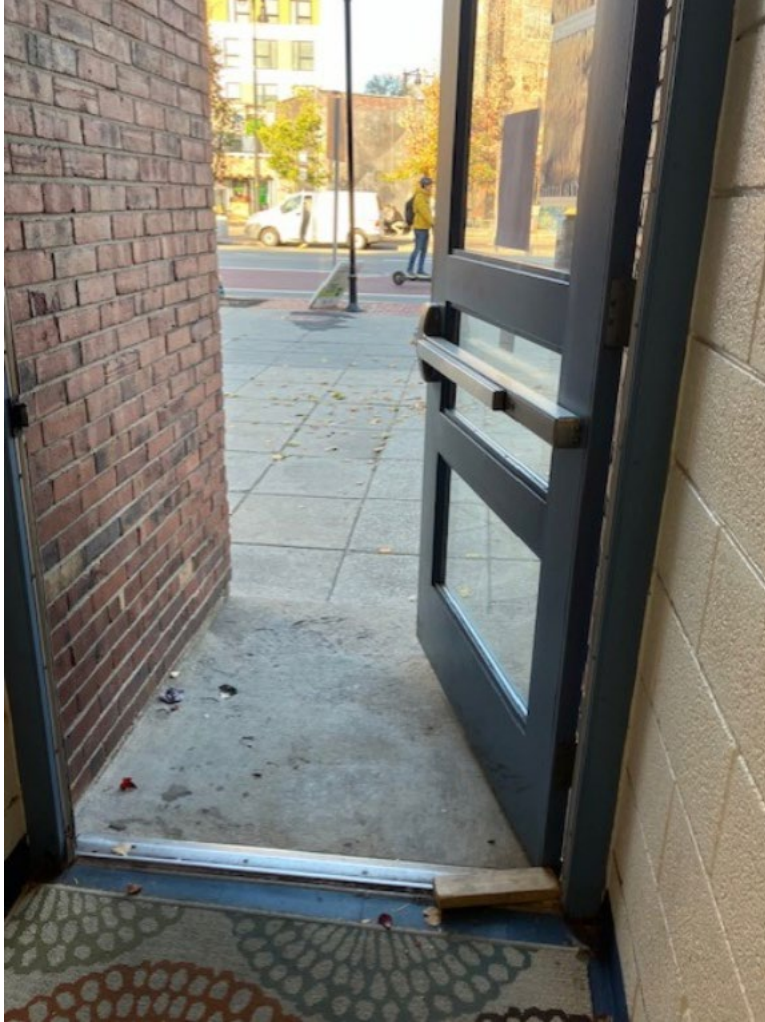
A door is being propped open and partially obstructed by a wooden block. The door opens onto the street. The doorway appears narrow, under 32 inches wide between the doorway and brick wall.

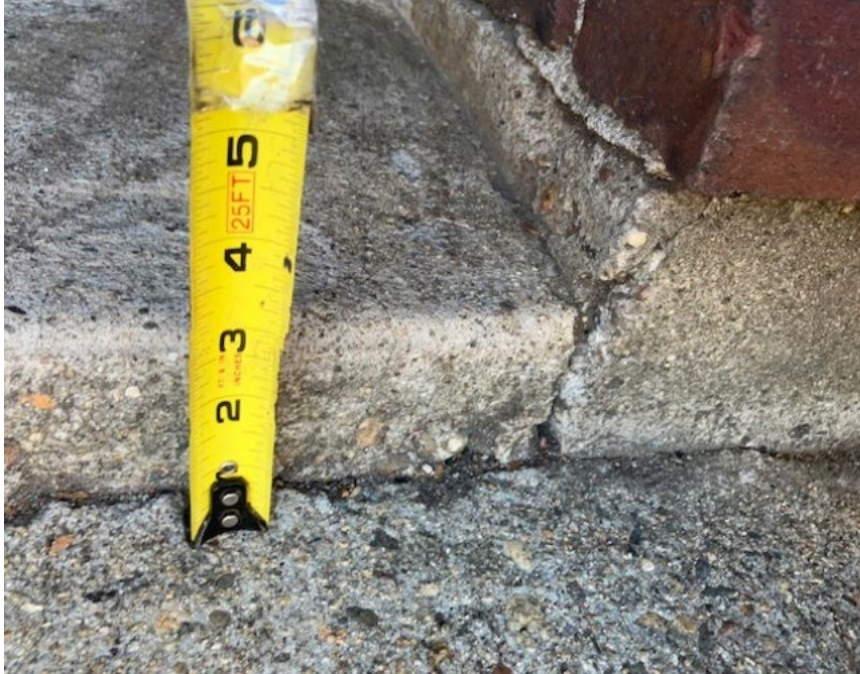
A tape measure shows that an uneven cement landing measures three inches above the ground.

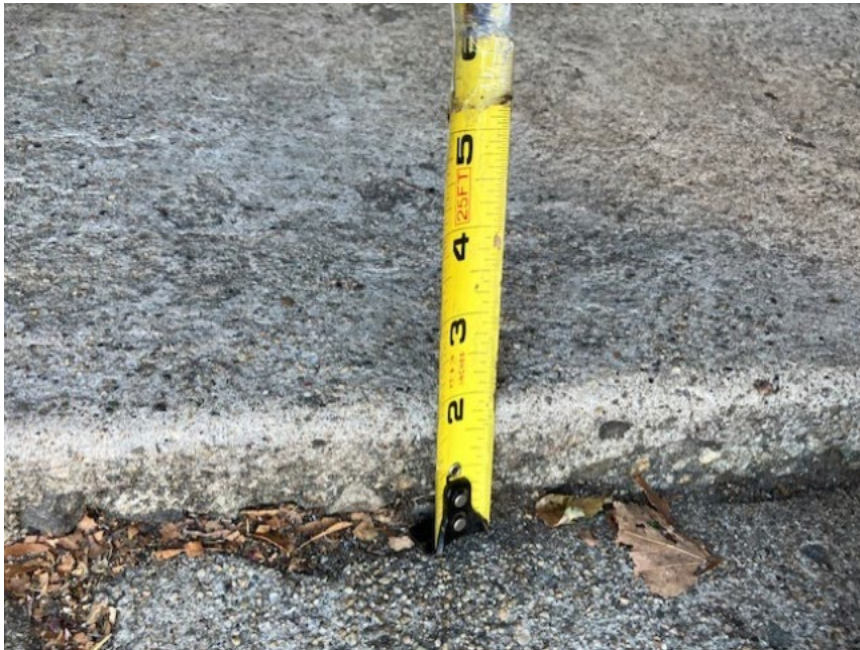
A tape measure shows that an uneven cement landing measures two to three inches above the ground.

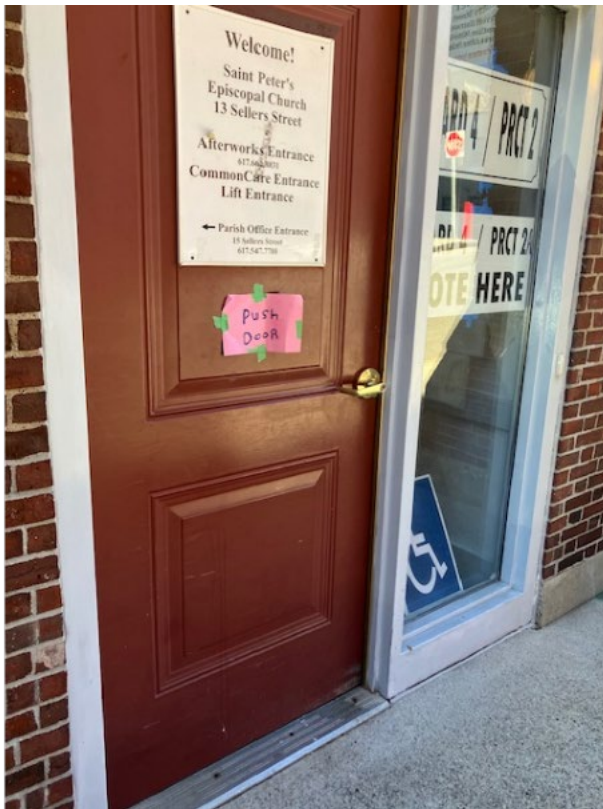
The entrance to Saint Peter's Church. A note is taped to the door reading Push Door. A sign containing the International Symbol of Accessibility is placed inside the window next to the door. The surveyor noted that this door felt heavy.

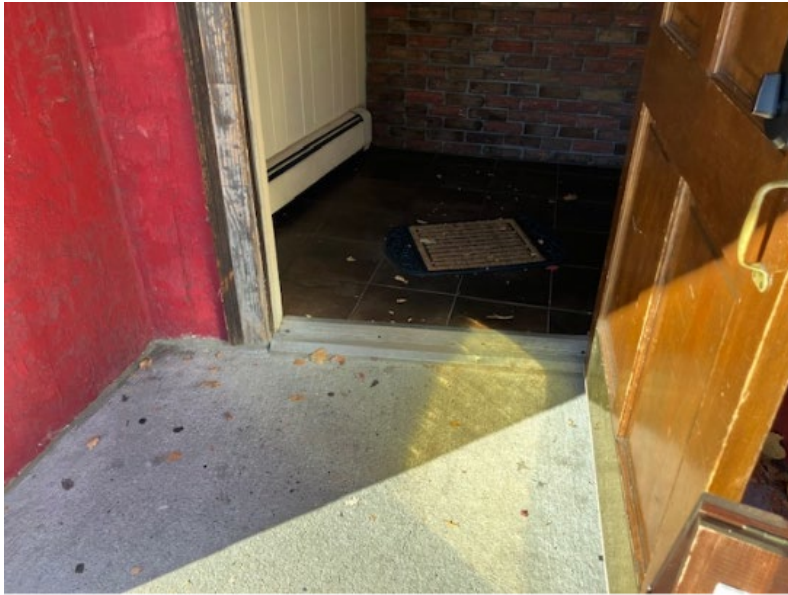
Close up of the Medford Professional Fire Association entry doorway. The door is held open, and there is a metal threshold greater than ½ inch in the doorway.

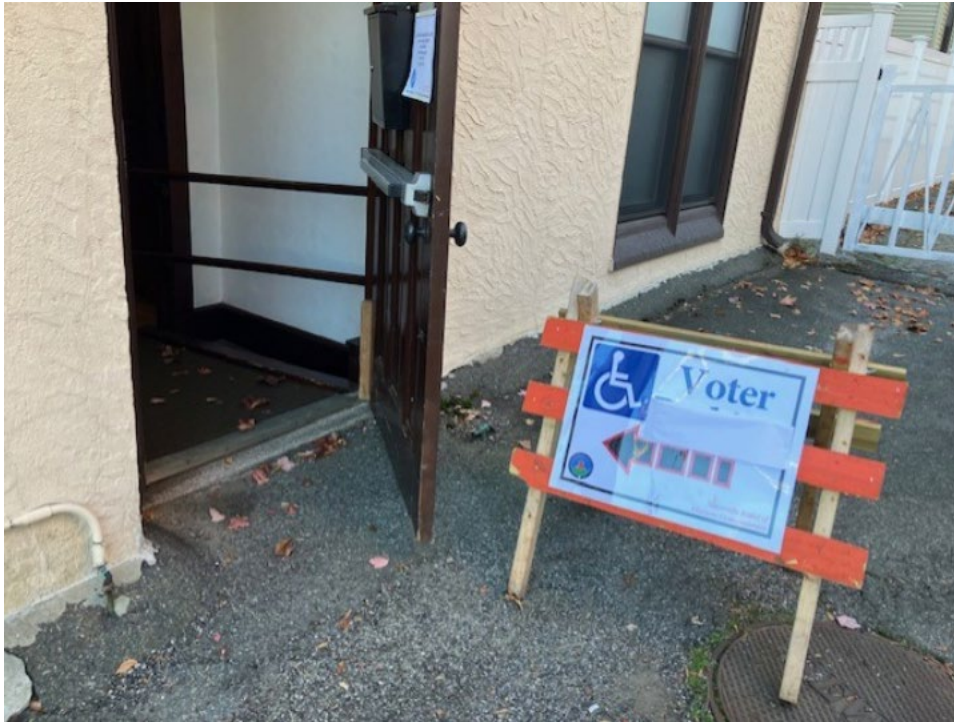
## Brazilian Presbyterian Church Somerville Photos

The accessible entrance to the Brazilian Presbyterian Church. The entry door is being propped open about three quarters of the way, posing a barrier to people using mobility devices. A sign next to the door contains the International Symbol of Accessibility and points to the entrance. The sign, partly closed door, and threshold are potential barriers to the accessible path of travel.

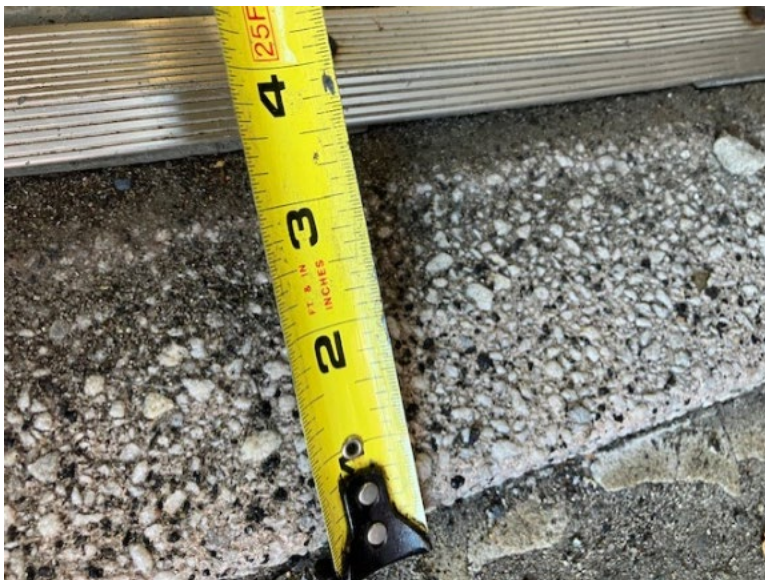
A measuring tape in front of a threshold to enter the Brazilian Presbyterian church. The threshold measures between two to three inches high.

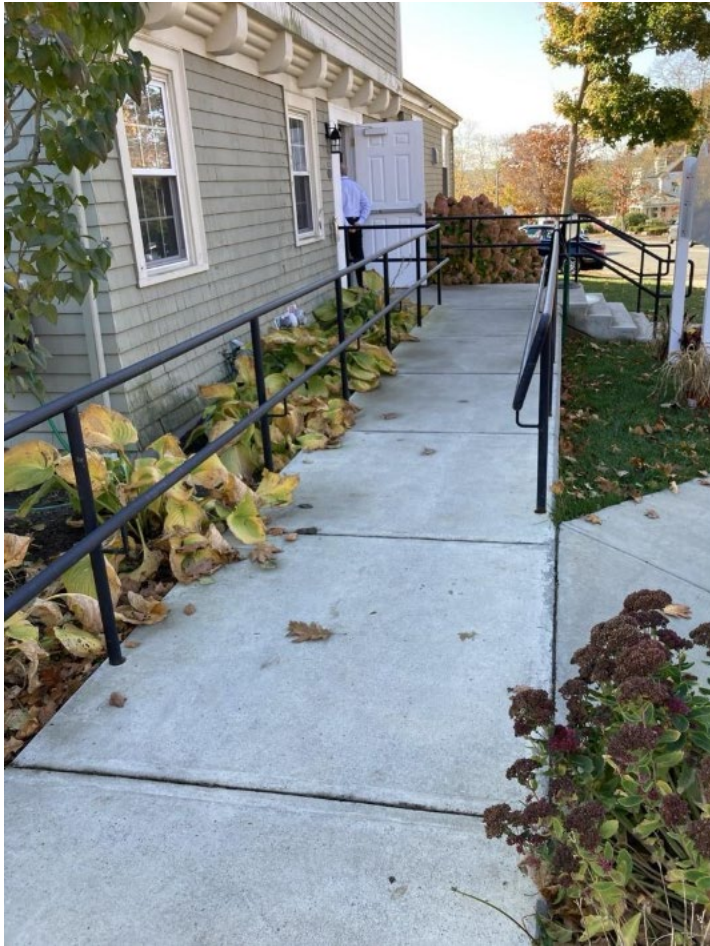
The ramp leading to the Magnolia Library front entrance. The surveyor noted that this ramp was too narrow, less than 48 inches wide.

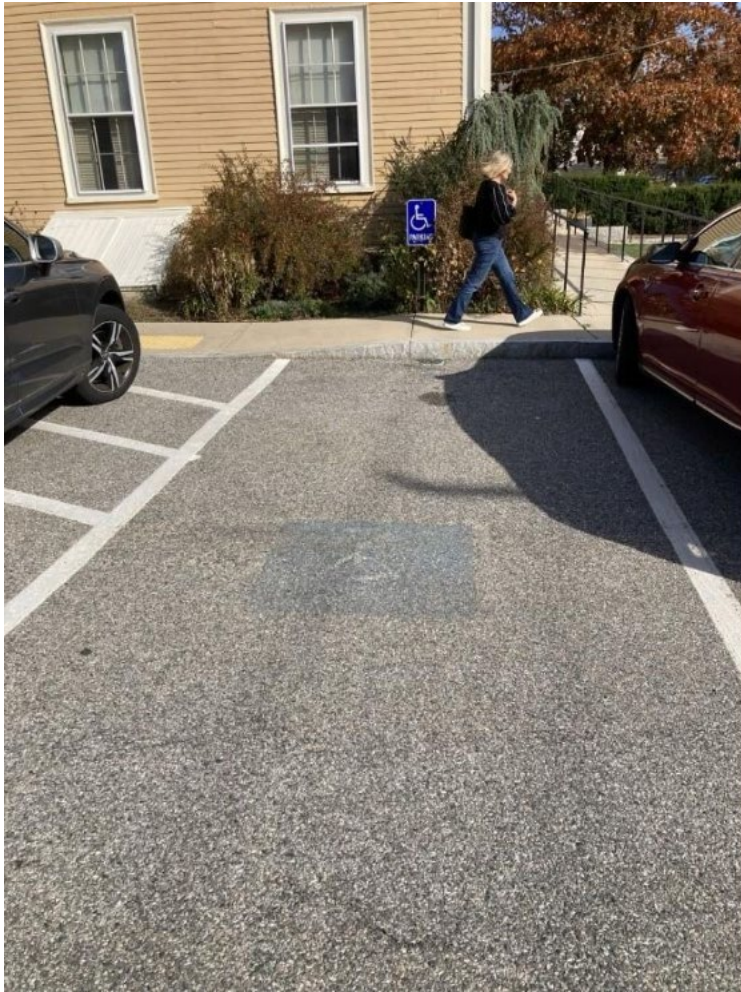
An accessible parking space is pictured in front of the Rockport Community House entrance. The blue parking sign with the International Symbol of Accessibility stands less than 4 feet high in front of the parking space.

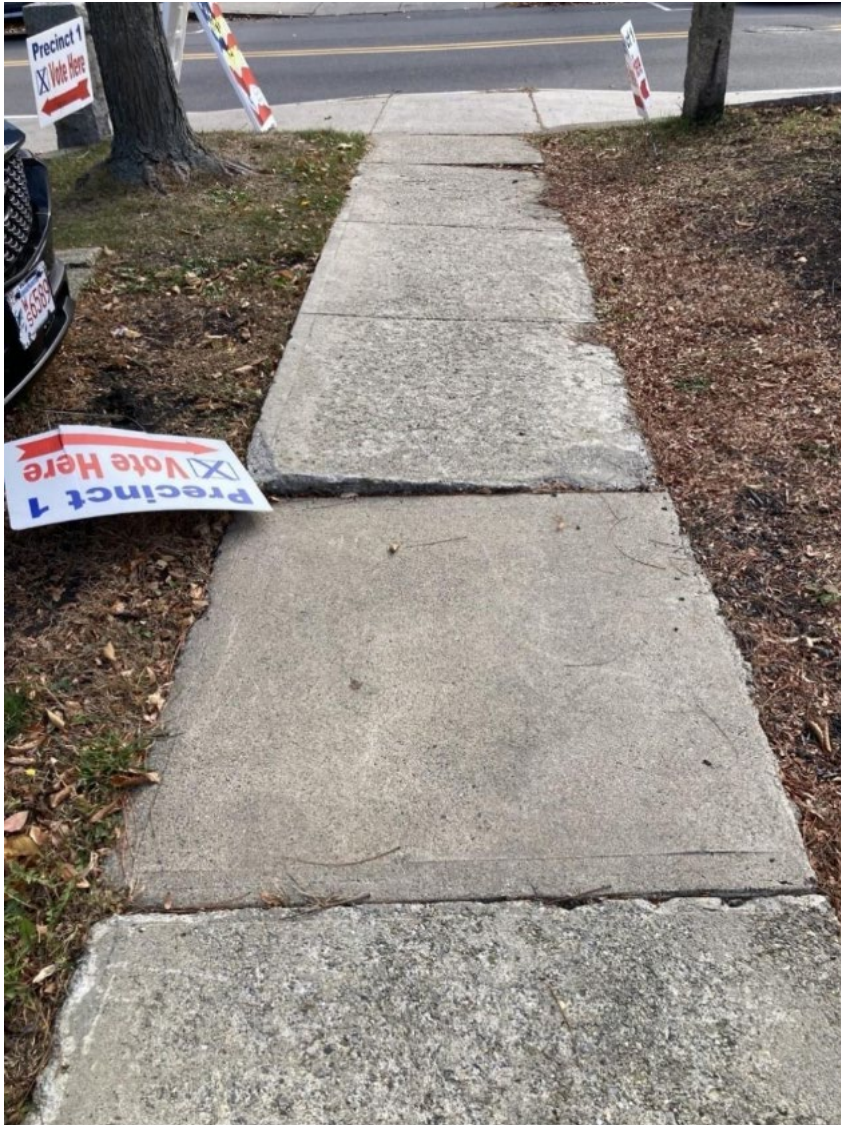
Concrete walkway to the Rockport Town Hall Annex. The sidewalk has uneven and lifting concrete, creating a step of an inch or two above the ground.

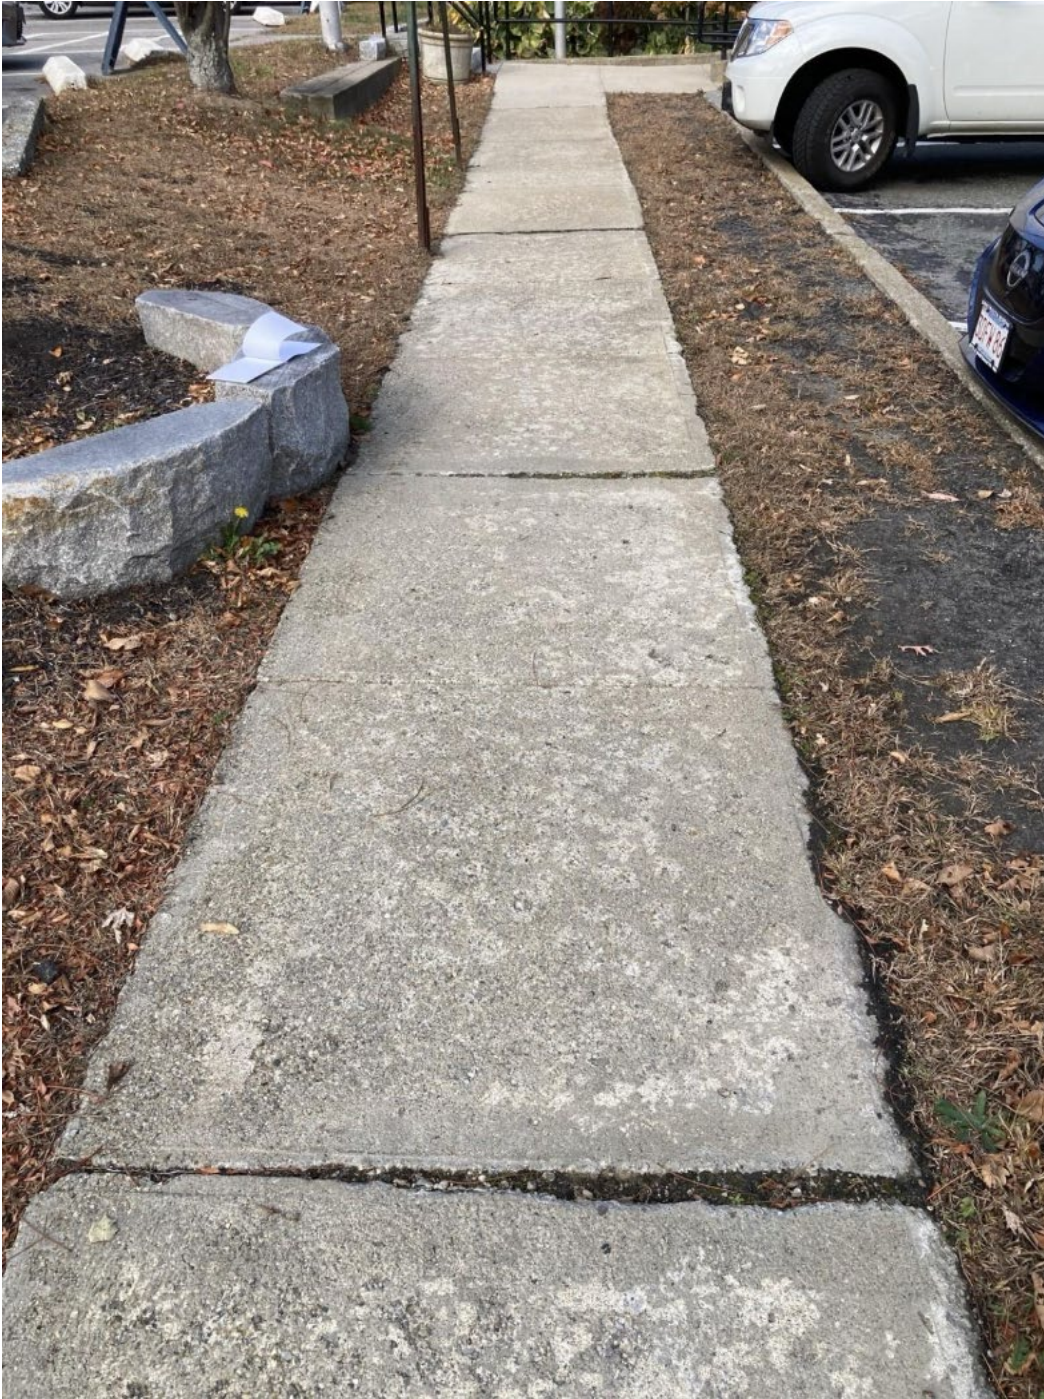
The uneven sidewalk leading to the Rockport Town Hall Annex.

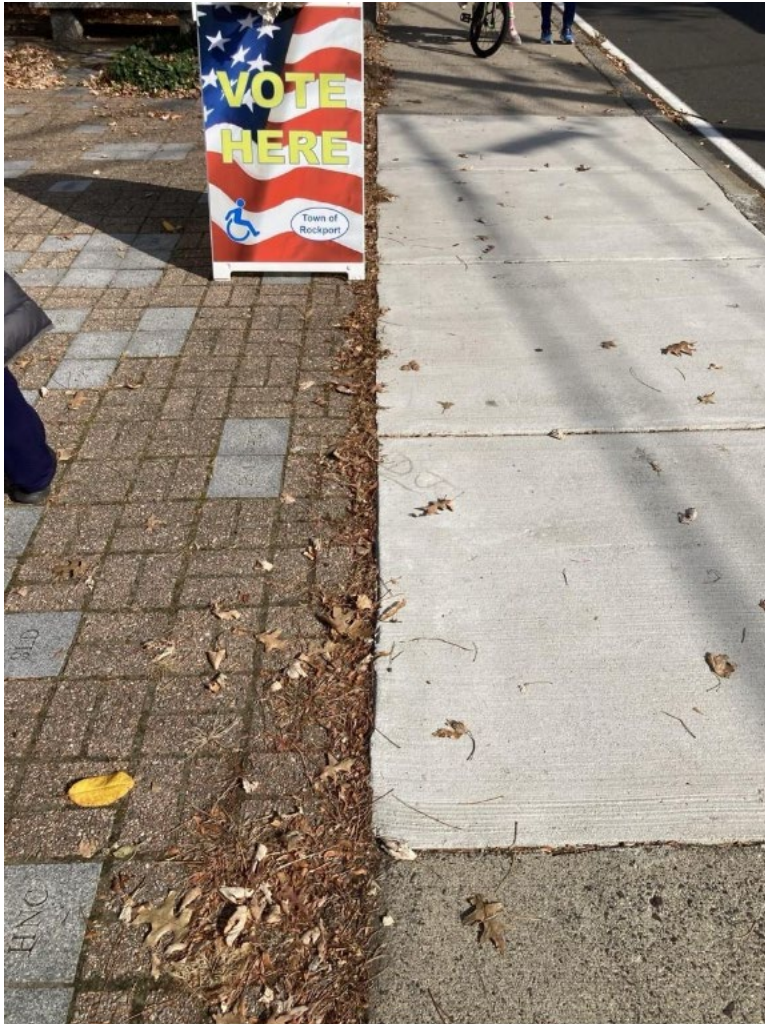
## Saint Mary's Episcopal Church Rockport Photos

A sidewalk lining the street next to Saint Mary's in Rockport. There is an area of brick next to the cement sidewalk with a difference in level greater than half an inch.

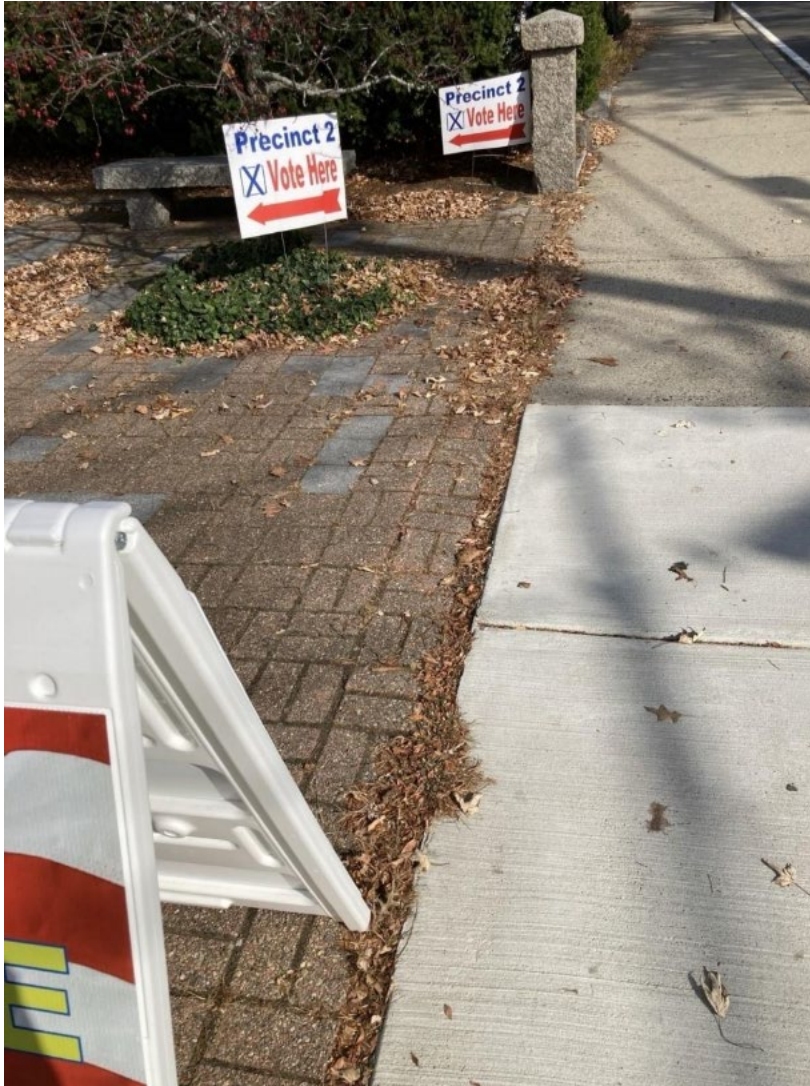
A level greater than a half inch between the concrete and the brick interrupts the path of travel between the signs.

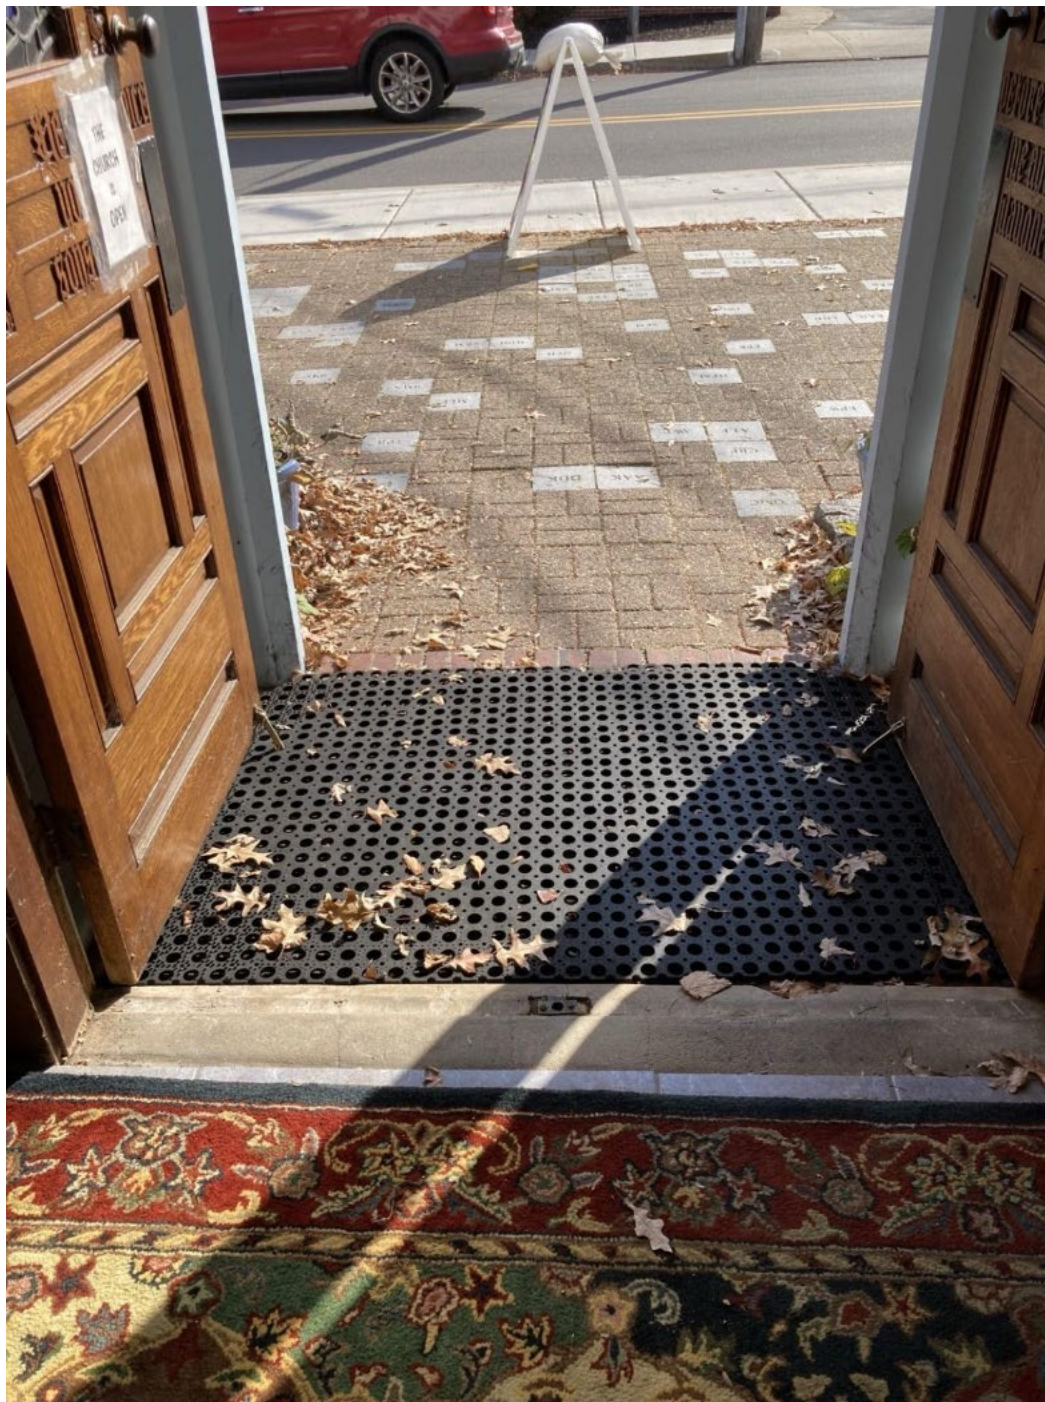
View of the entryway of Saint Mary's Church from the inside of the building, facing towards the street and brick area in front of the church. A concrete threshold of roughly ½ inch to one inch tall disrupts the path of travel.

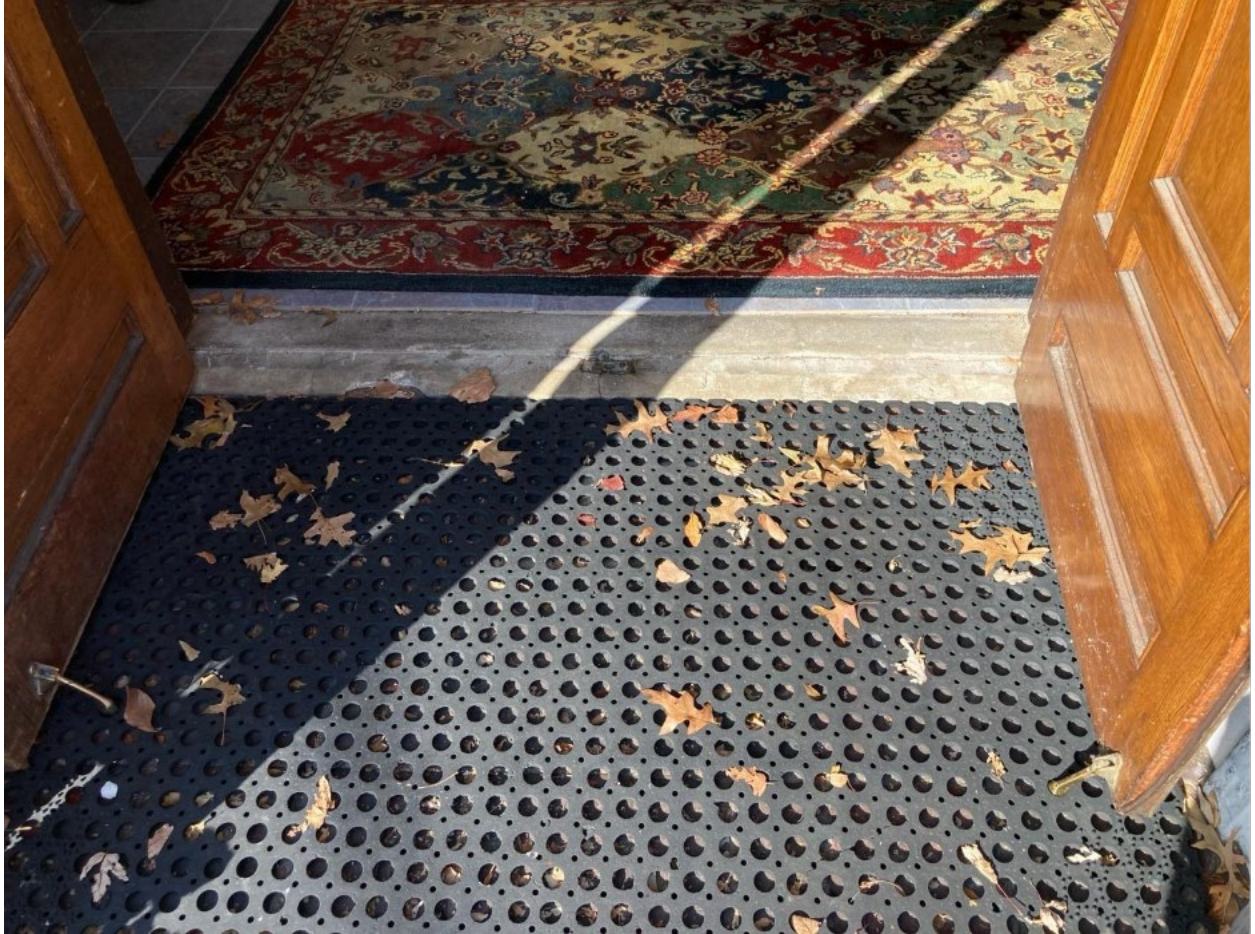
Saint Mary's entry doorway from the exterior area in front of the doors. A black rubber mat is placed in front of the doors and threshold which measures over ½ inch above the ground.

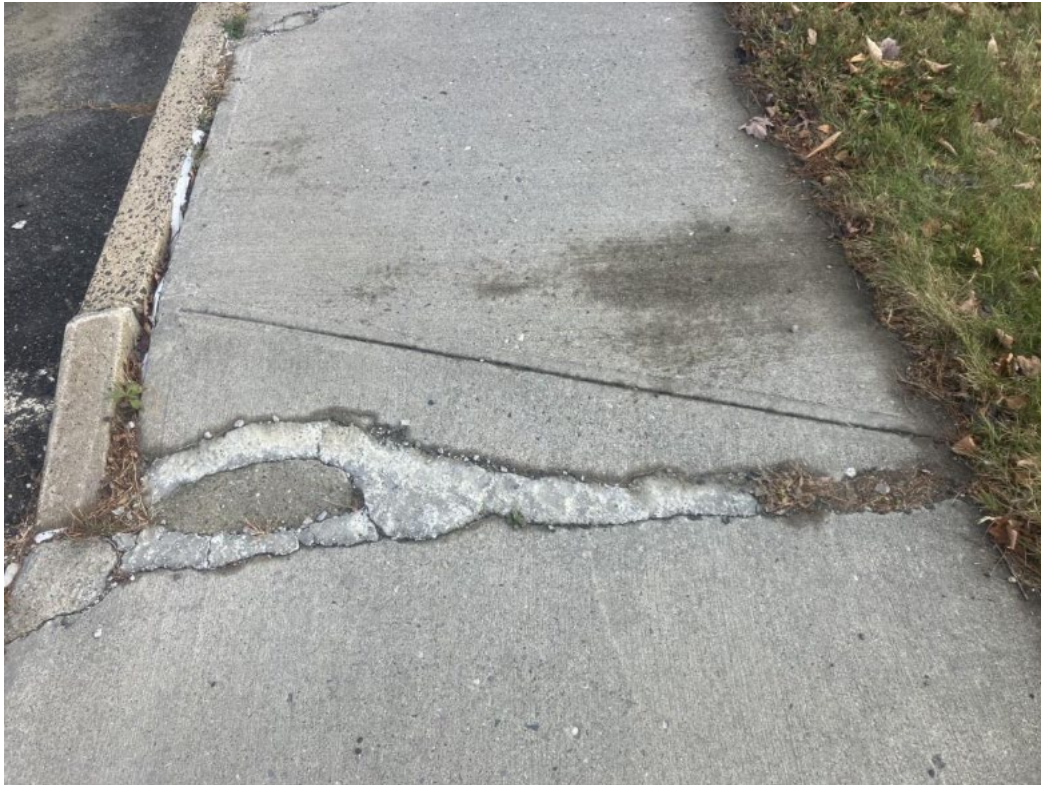
A sidewalk in front of the accessible parking spaces leading to the 18 Jacobs Road Municipal Center. The side flare on the curb cut has a large crack running through it, and the curb lining the sidewalk is partially lifted from the ground. The crack is patched in some places but is uneven.
