# Voting Accessibility in Massachusetts: 2024 General Election

Report by  
Disability  
Law  
Center,  
Inc.

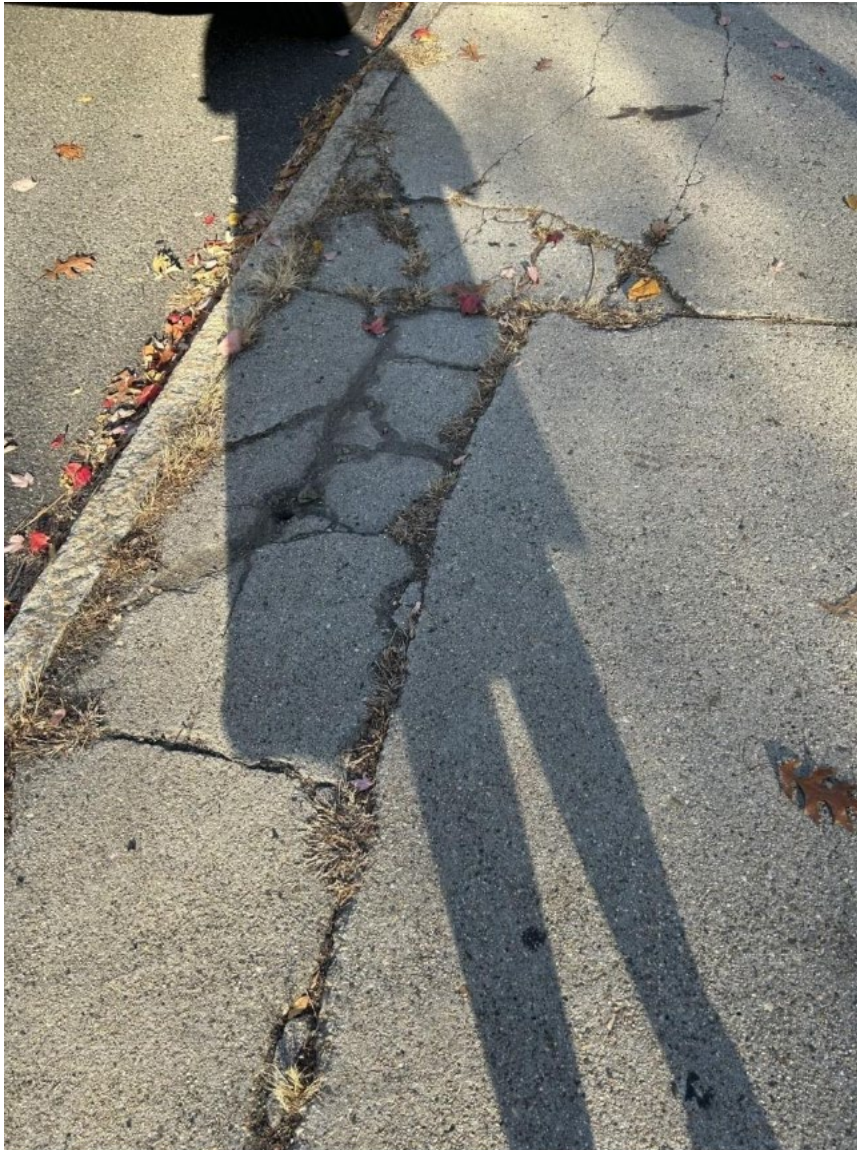
A cracked, uneven sidewalk in the path of travel to Saint Paul's Parish in Holyoke.

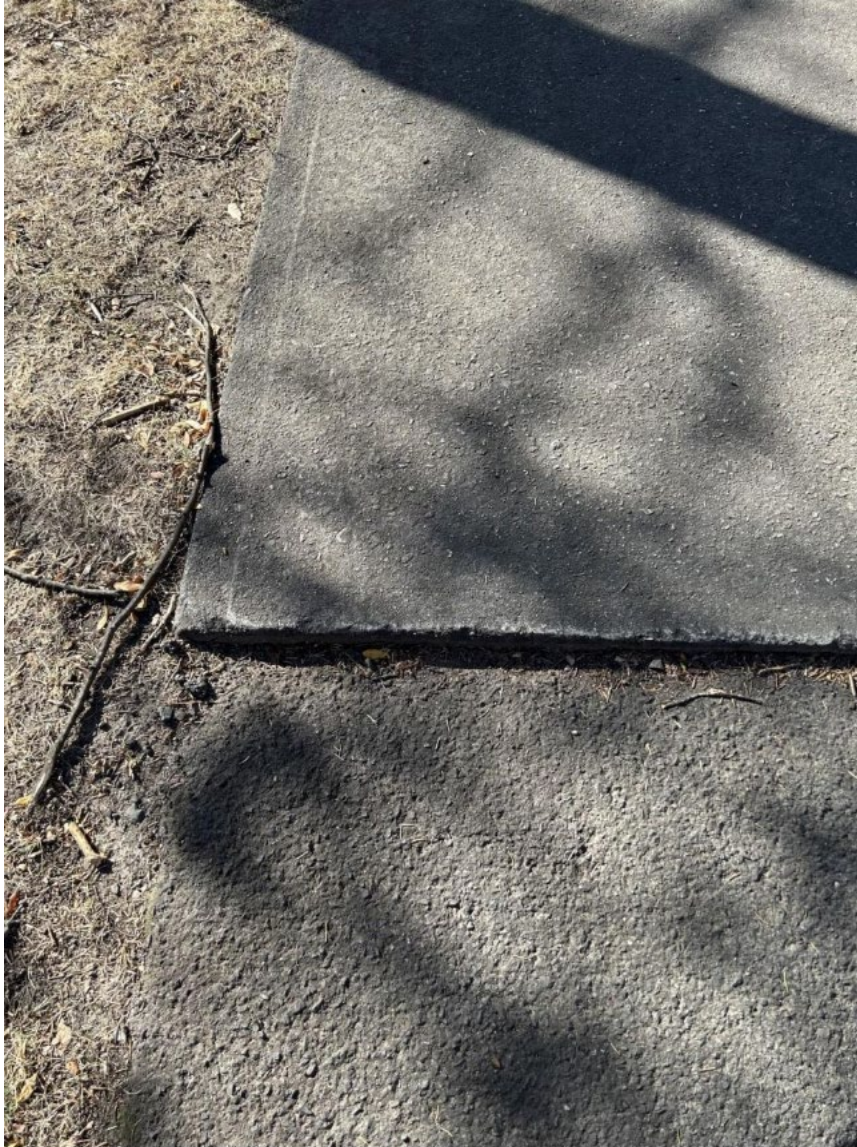
A cement slab of sidewalk in the path of travel to Saint Paul's Parish. The sidewalk is partially lifting, creating a change in level of over ½ inch.

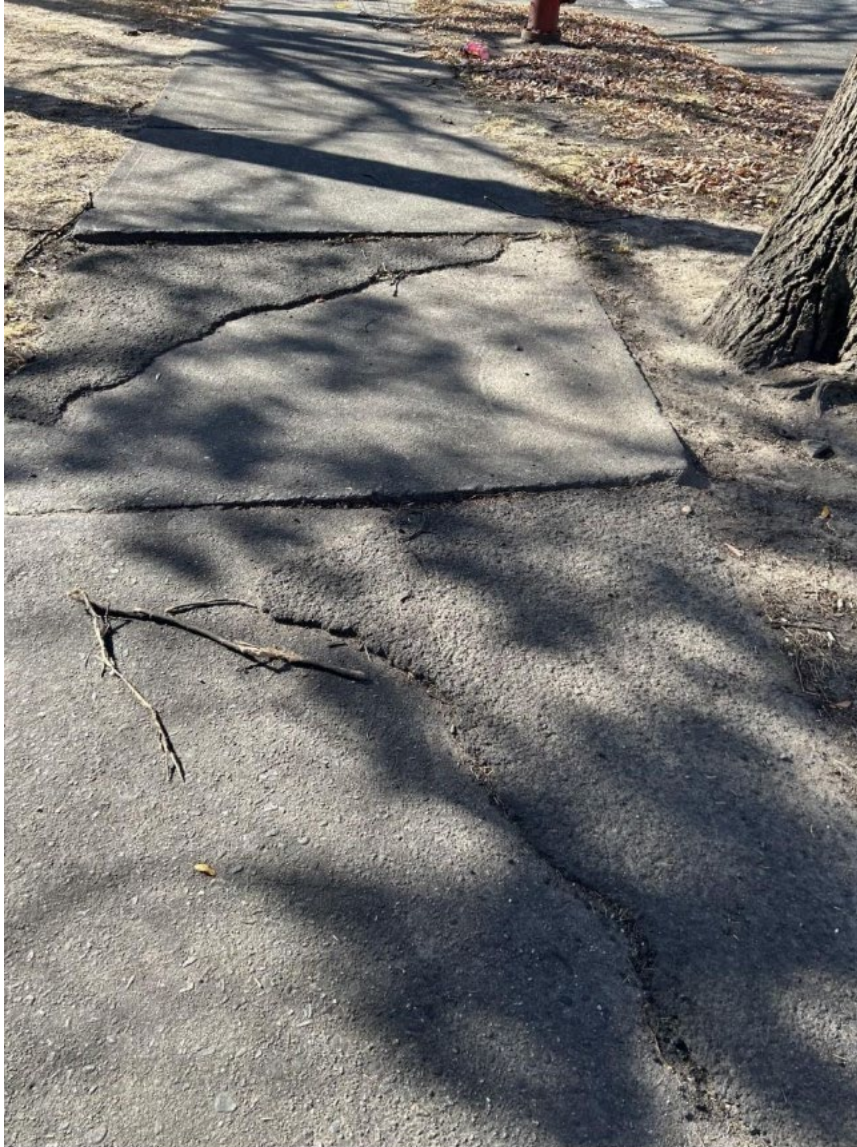
The sidewalk leading to Saint Paul's Parish. There are several cracks and uneven areas in the sidewalk, including areas where the sidewalk is lifting or where patches in the pavement create an uneven surface.

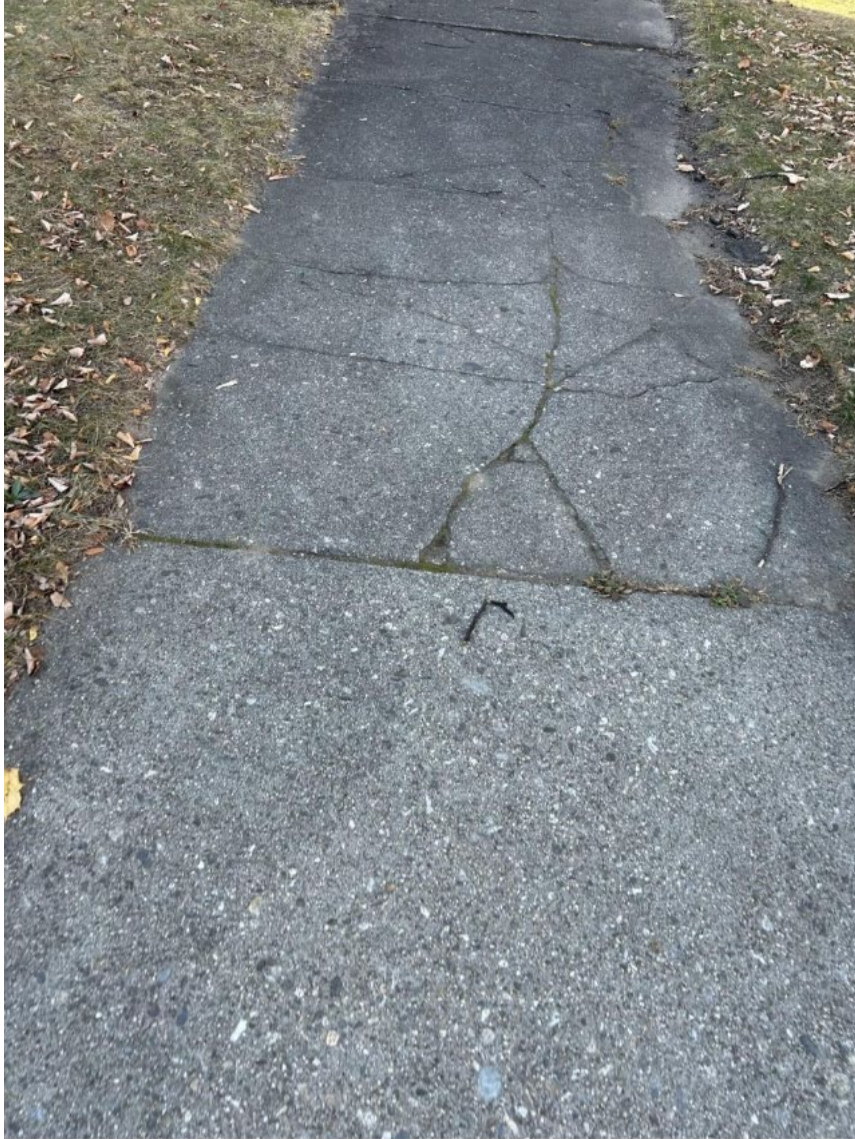
The sidewalk in the path of travel to Saint Paul's Parish. The pavement is cracked and caved in.

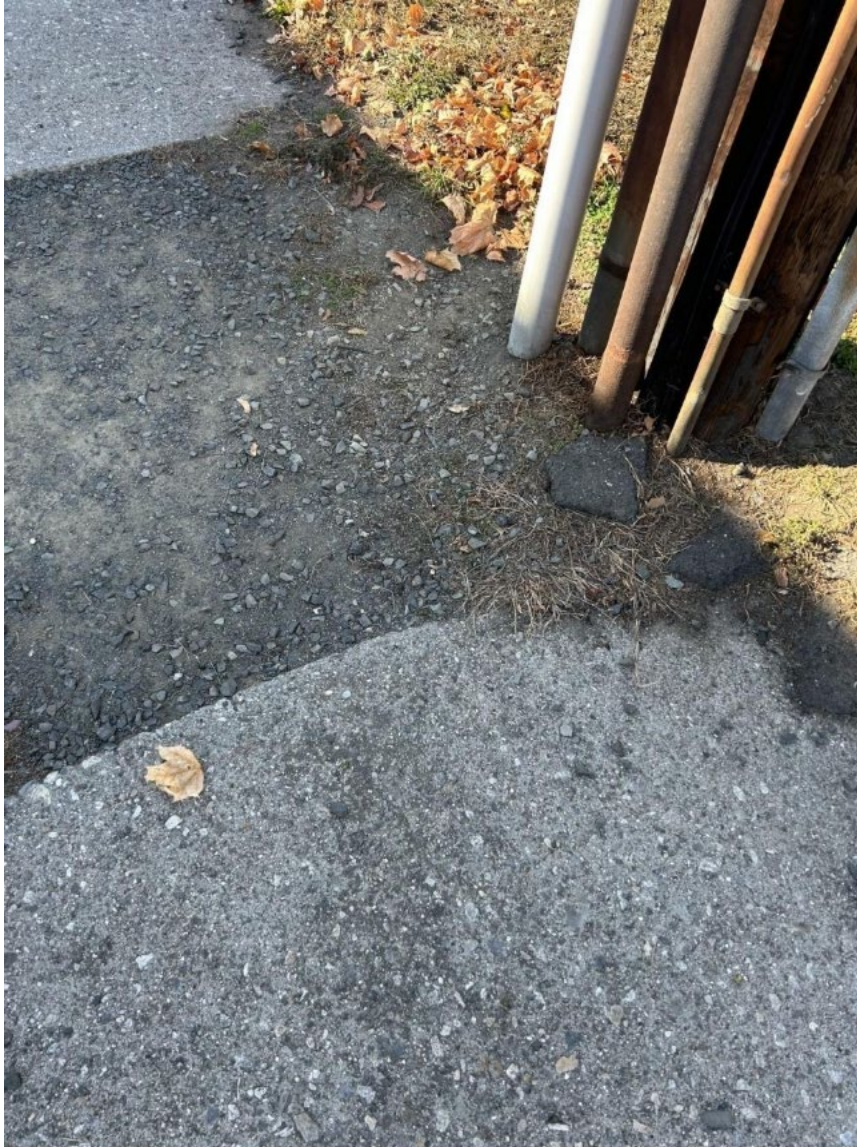
Patch of sidewalk in Holyoke where the pavement suddenly ends is filled with gravel and dirt, creating an uneven surface.

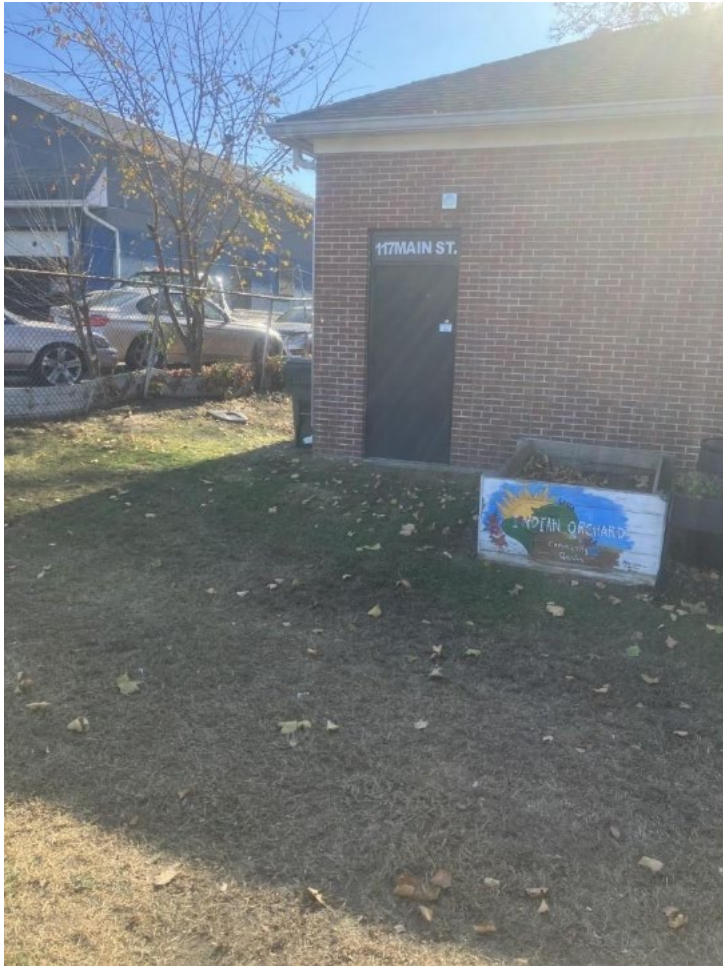
## Indian Orchard Citizen's Council Springfield Photo

Indian Orchard Citizens Council side exit or entrance door. The door leads to a grassy area and has a step down to the grassy area measuring roughly a few inches.

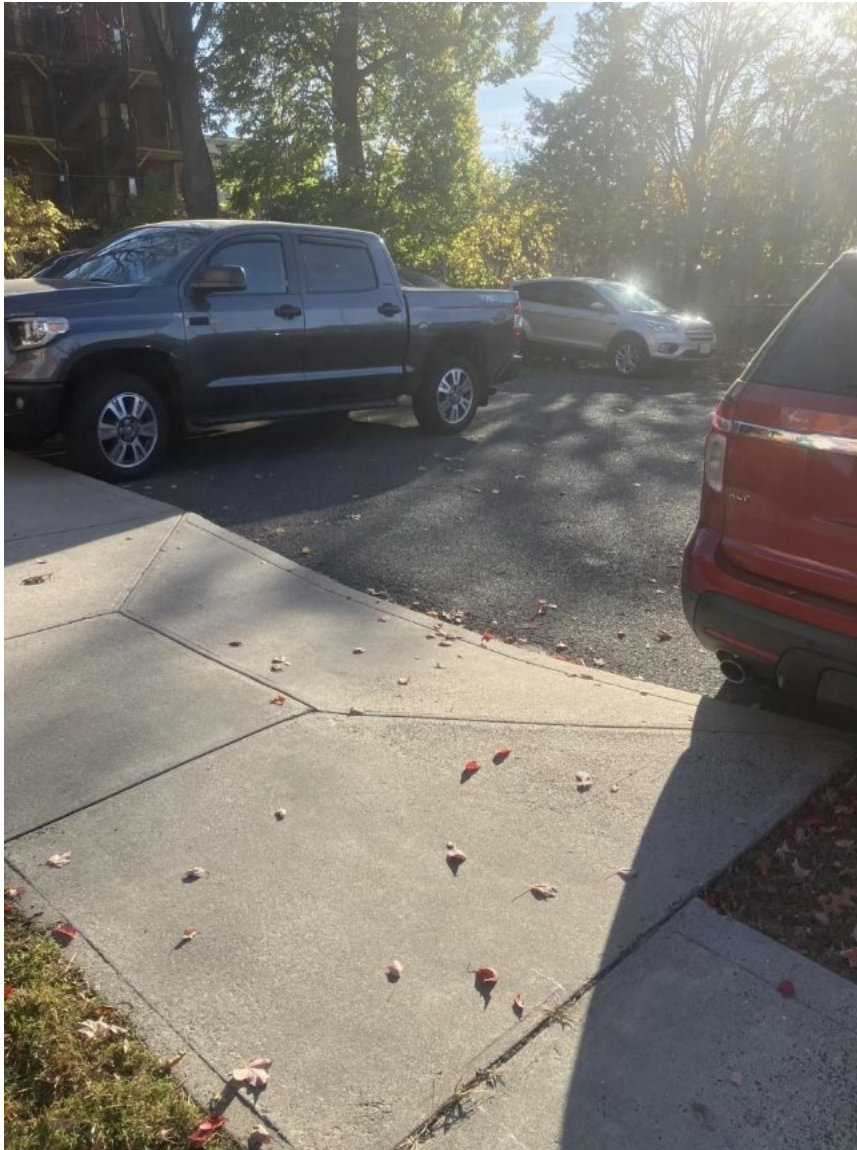
A close view of the curb ramp leading to the sidewalk from the parking lot of North End Youth Center. The curb cut is compliant, but the parking lot spaces are unstriped and no accessible parking spaces are marked.

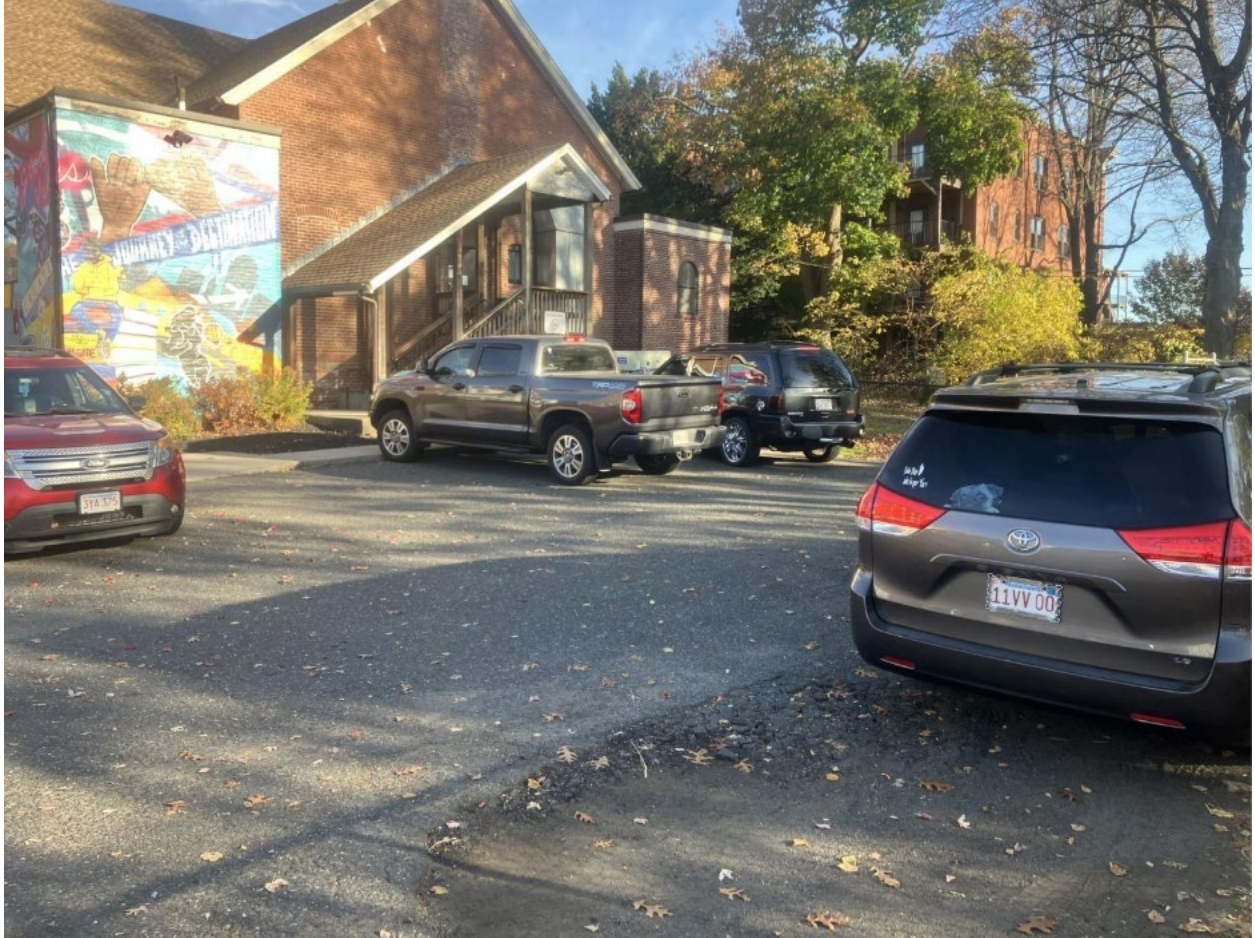
A view of the North End Youth Center parking lot from the sidewalk. There is a curb ramp visible in the distance, closest to the building. The parking lot is unstriped and unmarked otherwise.

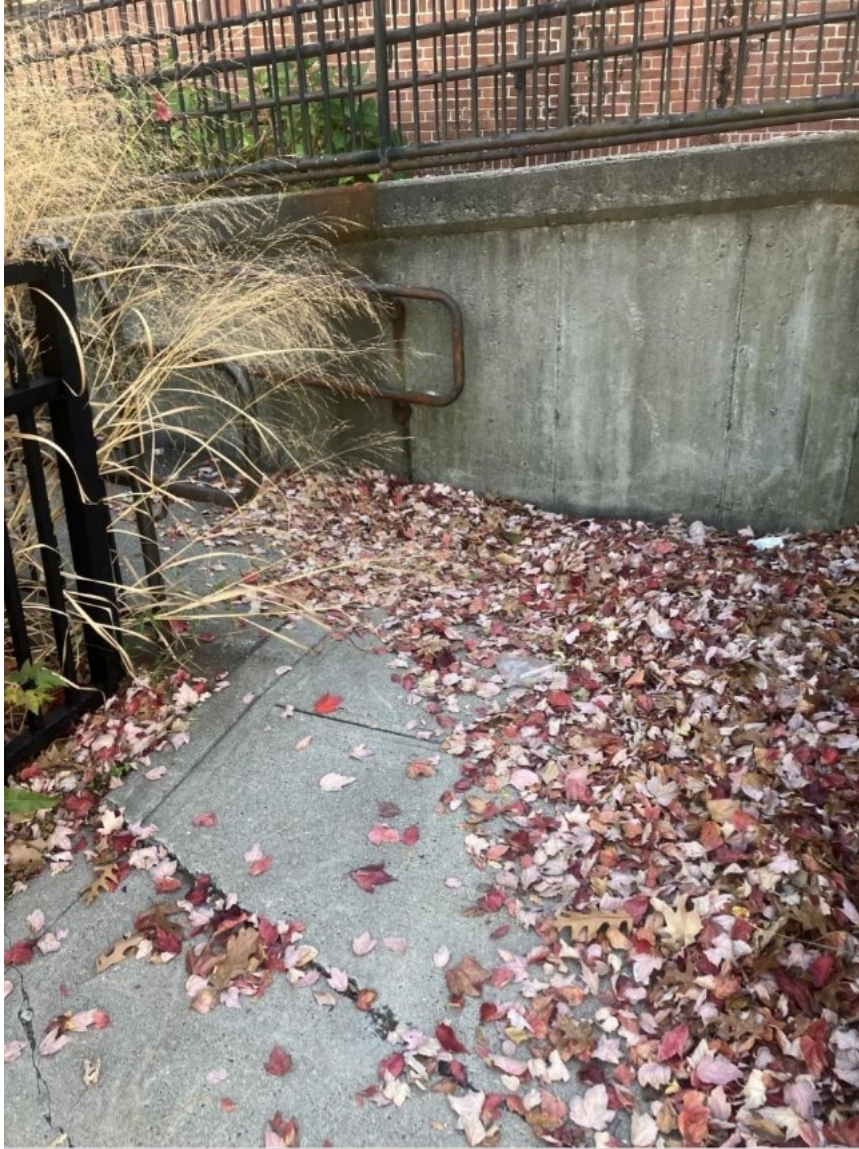
The bottom landing of the ramp at the North End Youth Center. The landing has a thick layer of leaves at the bottom which may be difficult for wheelchair users to navigate over.

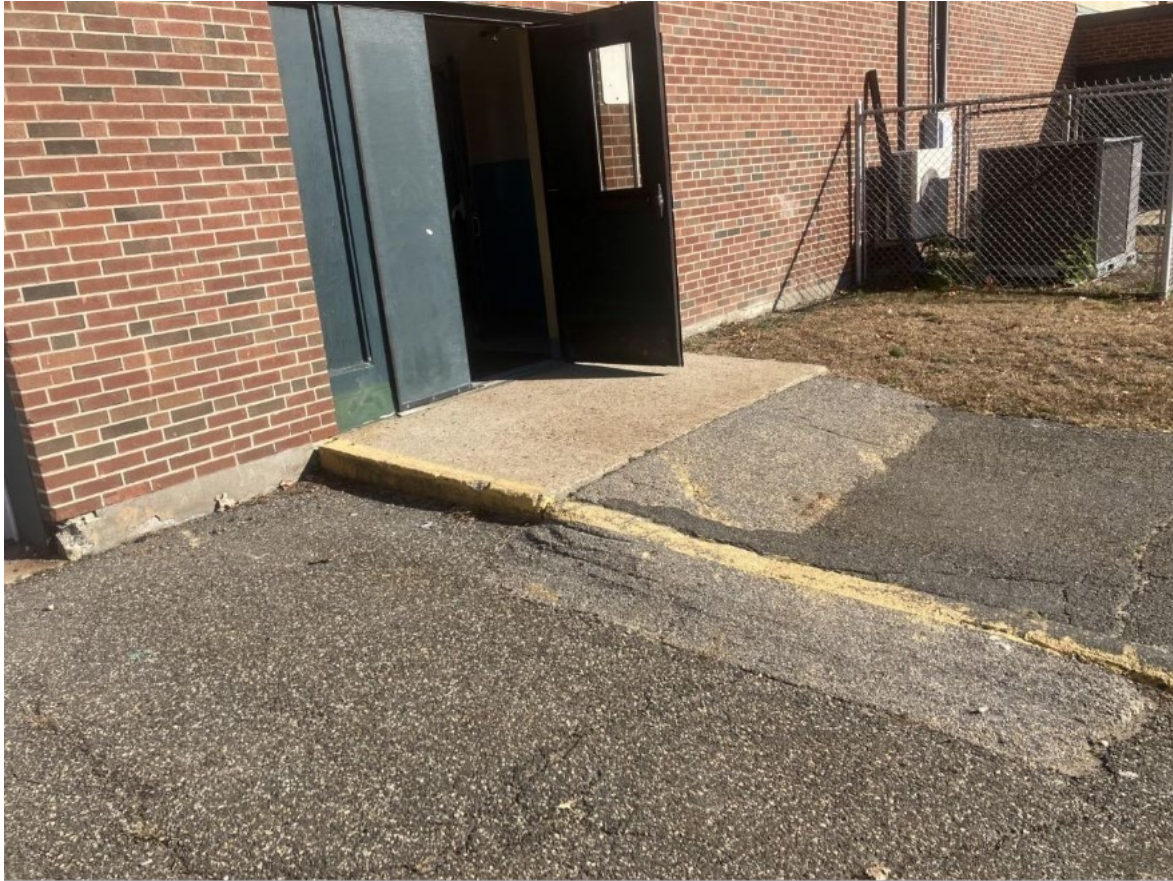
Path of travel from the parking lot to the entrance of the Springfield Boys and Girls Club gym area. Uneven pavement leads to the concrete landing in front of the door. It appears that the pavement has been shaved down to create a makeshift curb cut, but it is very uneven.

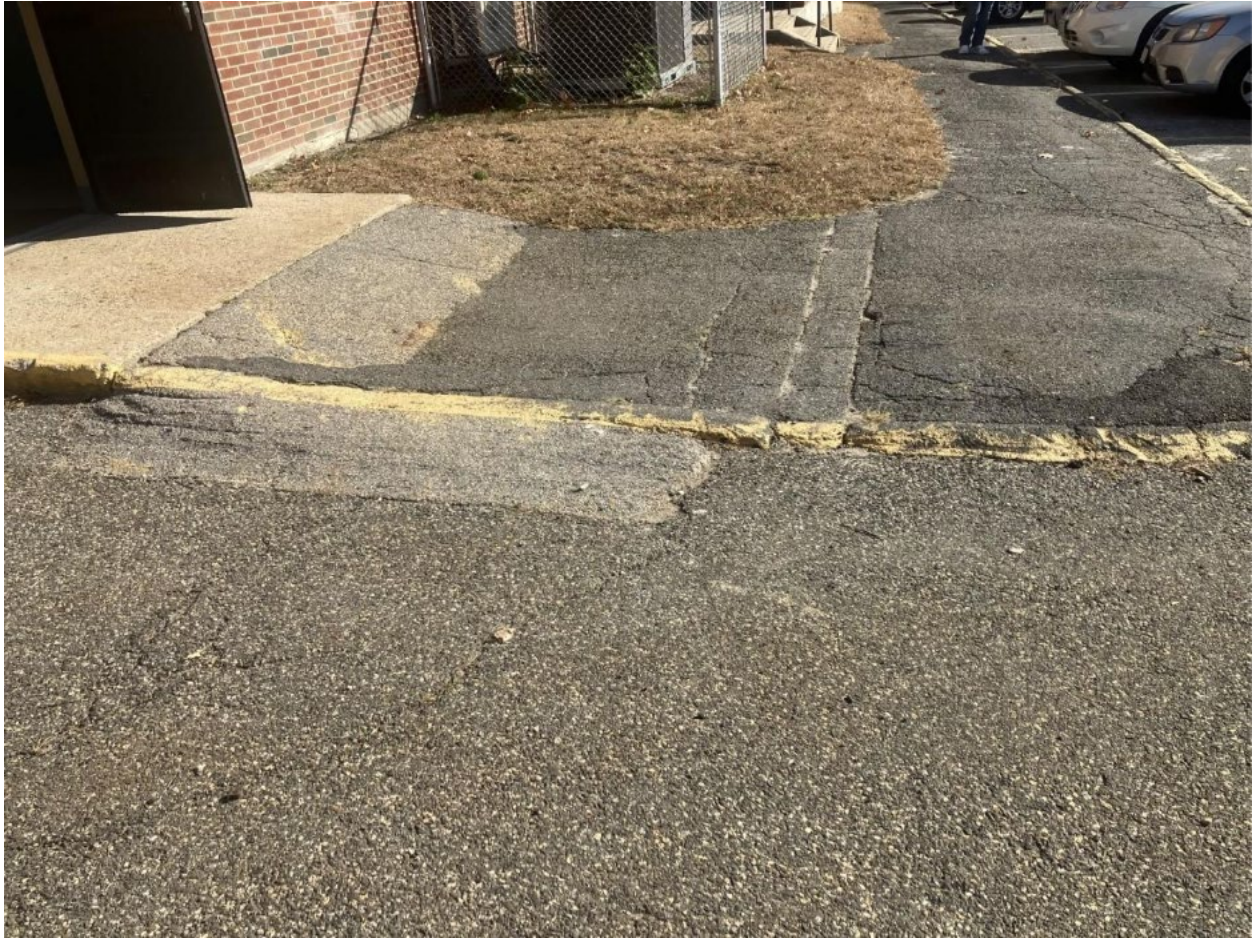
A closer view of the pavement in the path of travel to the polling place entrance. The pavement is uneven and cracked in multiple places and lacks compliant curb cuts.

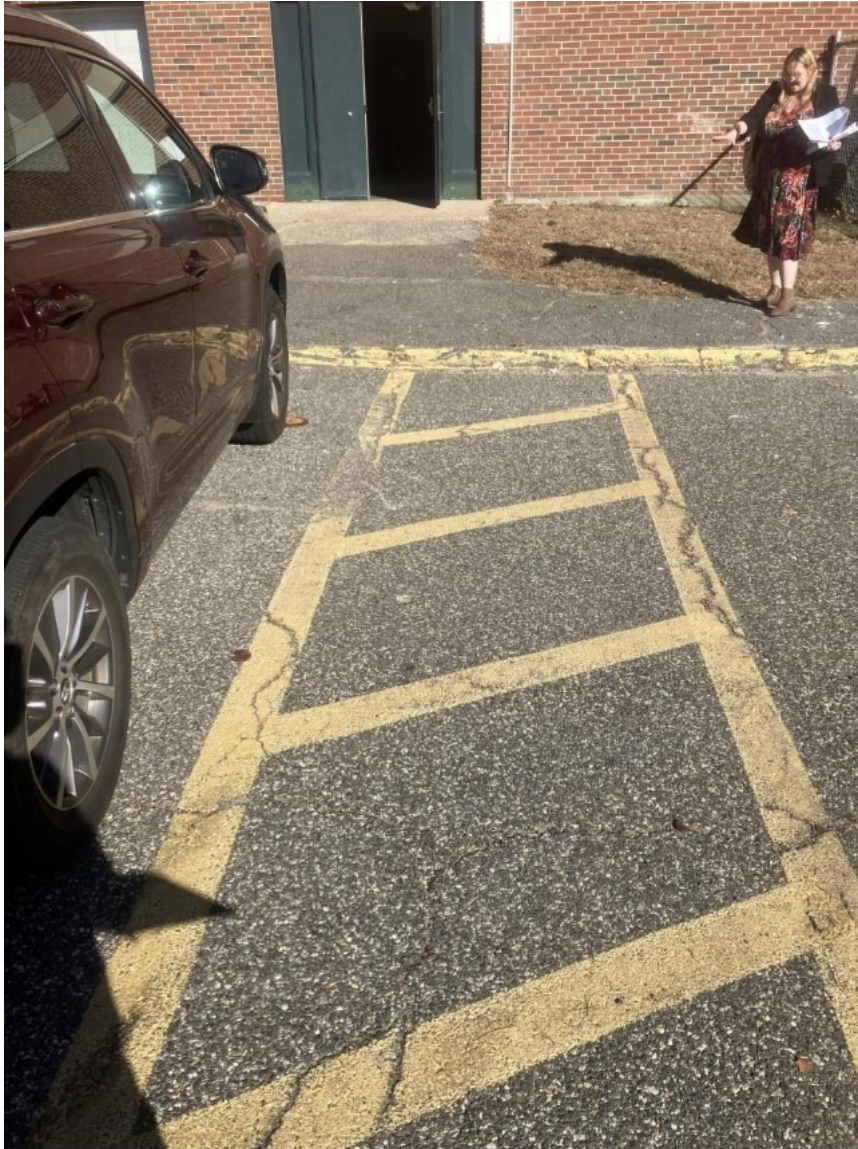
An accessible parking space and yellow striped access aisle leading to a curb in front of the polling place entrance. There is a yellow painted curb directly in front of the accessible parking space and no curb cut.

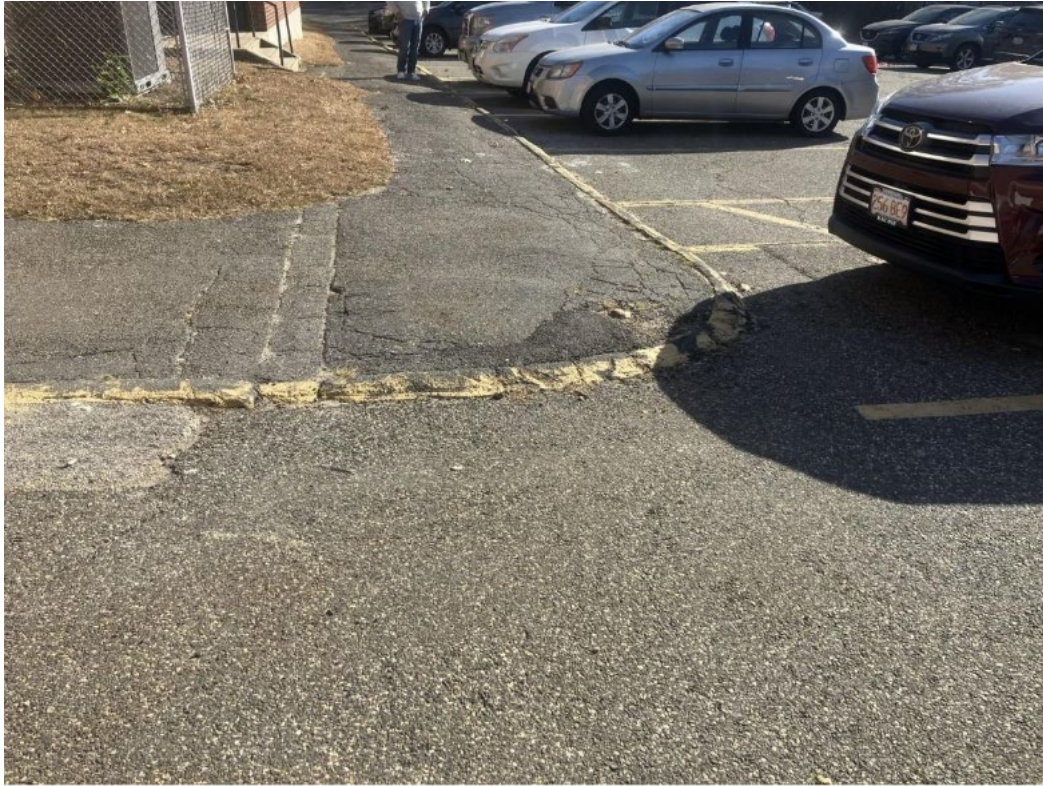
A closer view of the pavement and path of travel directly in front of the accessible parking space. There is a curb directly in front of the accessible parking spaces and the pavement is very broken and cracked in several places.

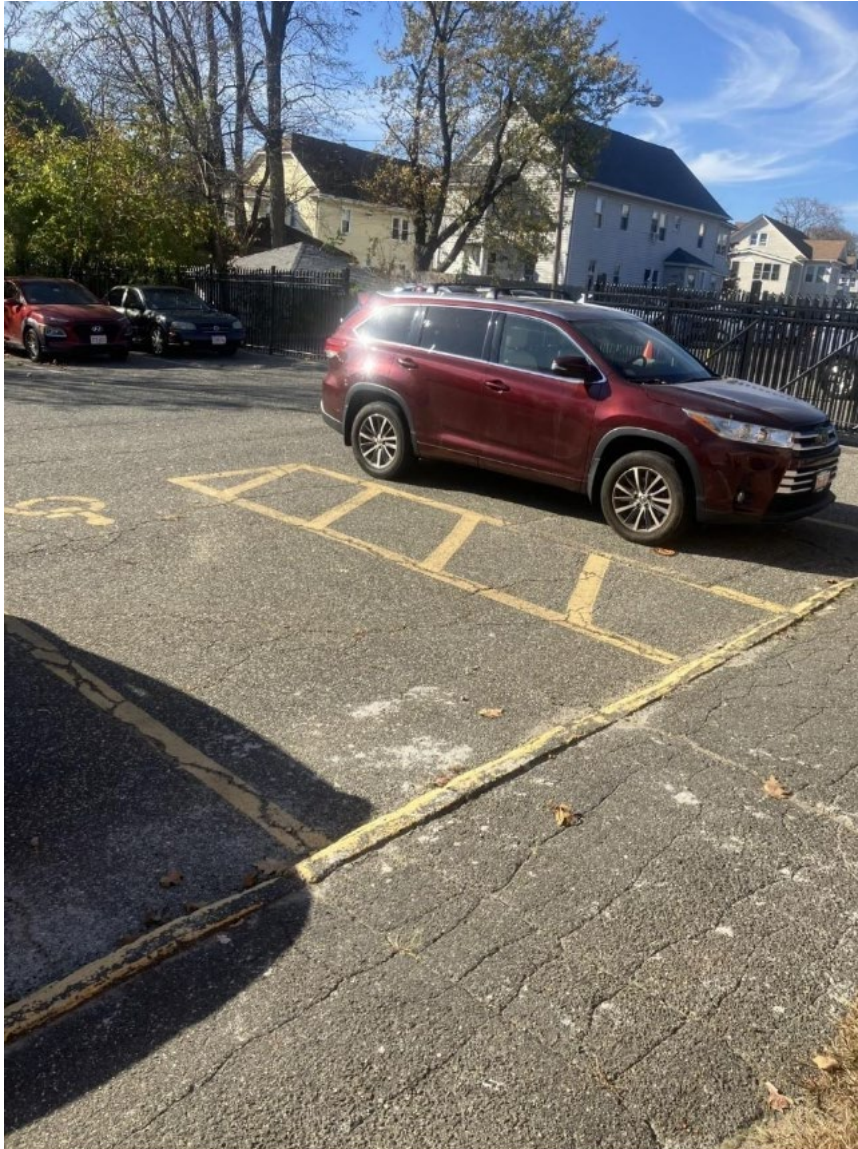
A side view of the accessible parking spaces located directly in front of the Springfield Boys and Girls club polling place entrance. The accessible parking spaces have a curb directly in front of the parking spaces, with no curb cuts.

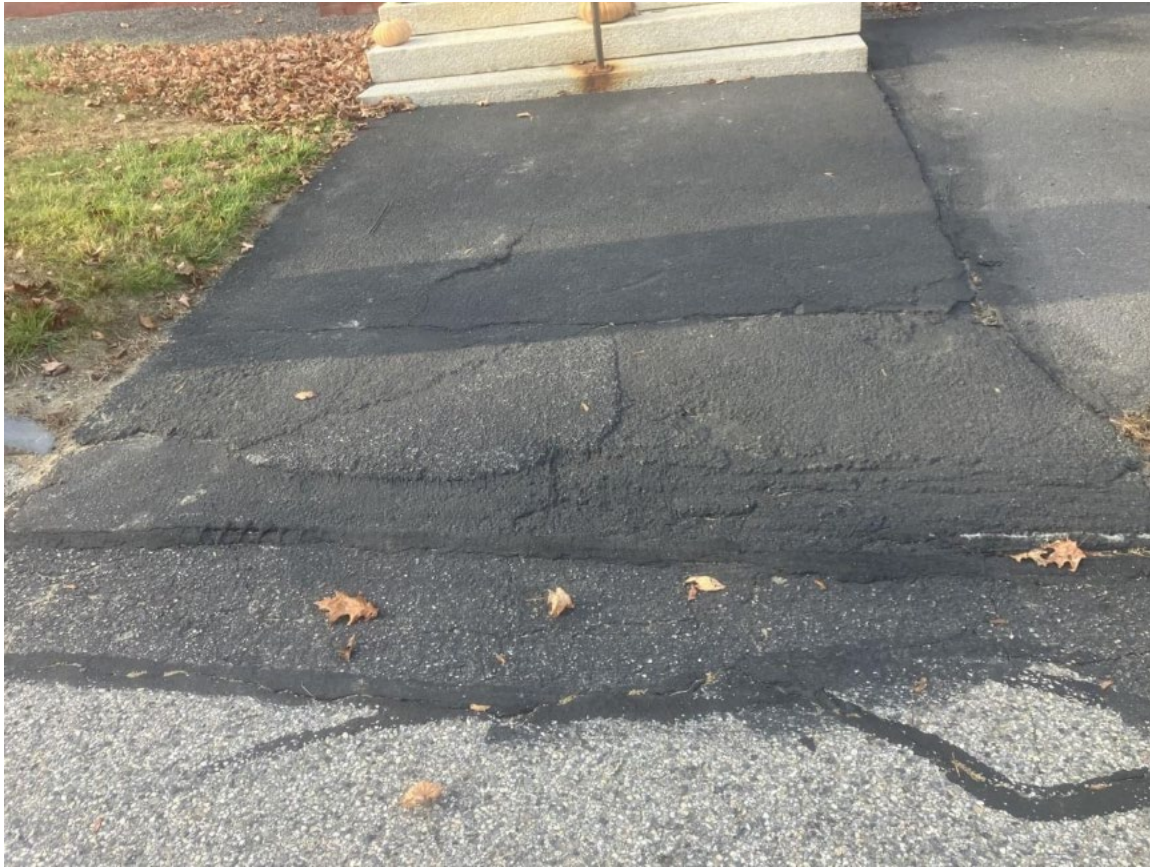
The path of travel to the Warwick Town Hall entrance. The pavement in the path of travel is patched and is not level. Behind the pavement is a staircase.

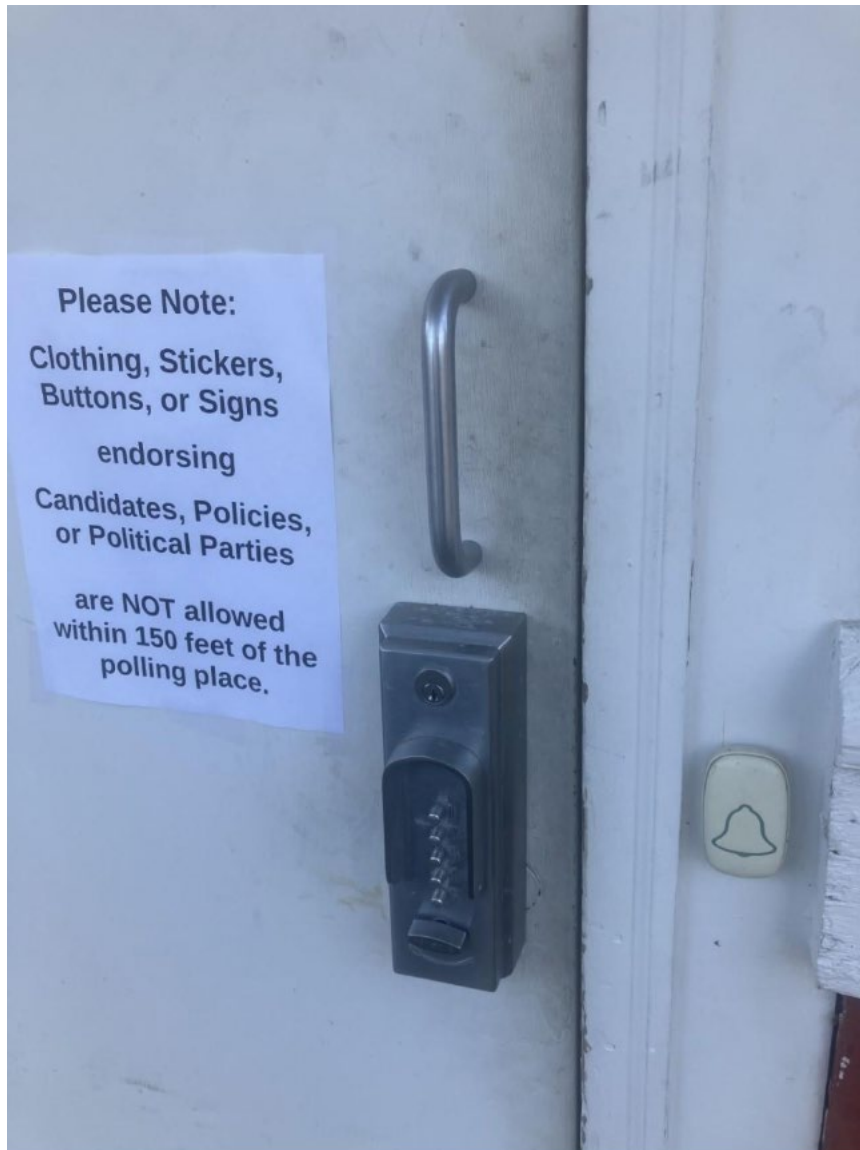
Entrance door to Warwick Town Hall. On the right side of the door there is a vertical door handle. The surveyor noted that the door handle was too high to be accessible.

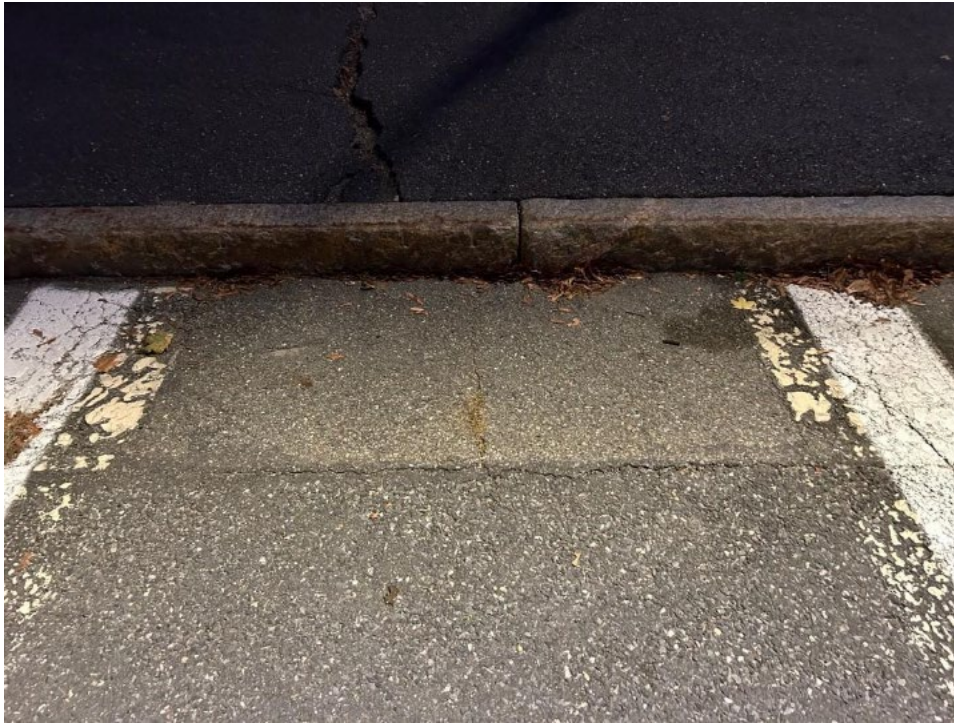
### Saint Joseph's Catholic Church Fitchburg

A curb where the sidewalk meets a crosswalk. The curb has a step up of roughly a few inches and lacks a curb cut/ramp.

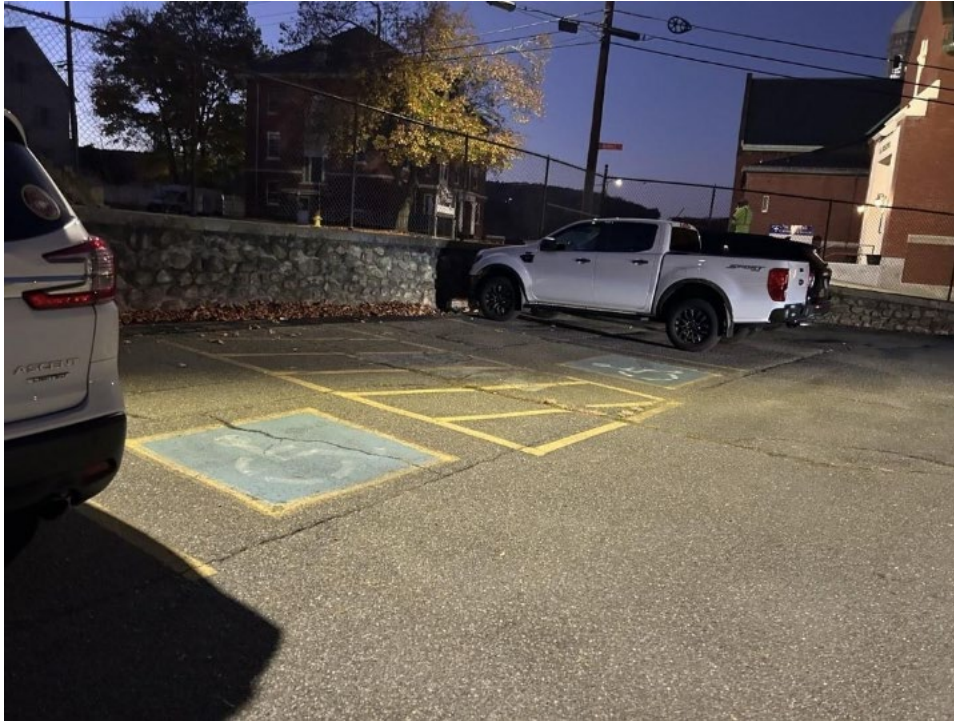
Two accessible parking spaces across the street from Saint Joseph's Catholic Church. The parking spaces have a stone wall directly in front of them and lack a curb cut to the sidewalk.

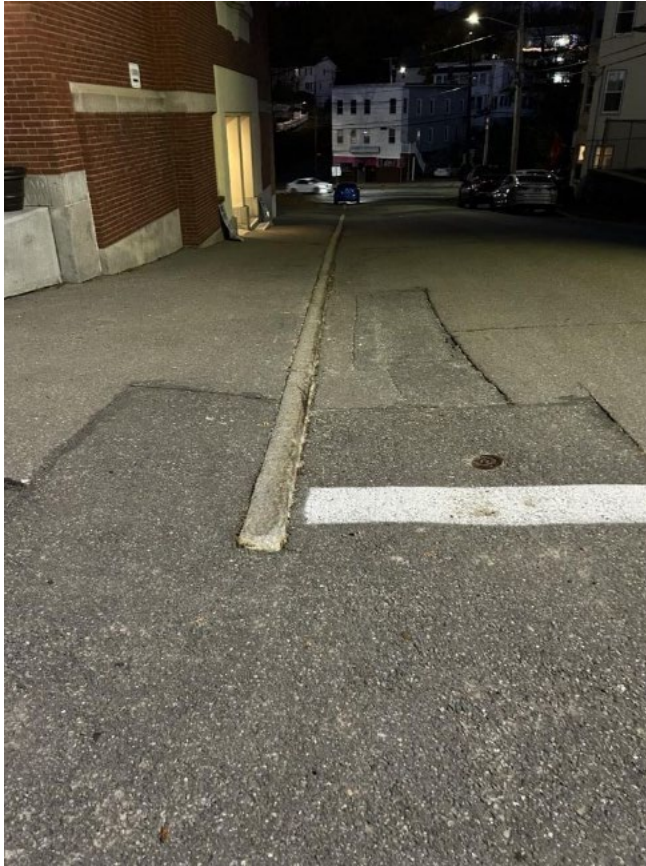
The path of travel from the viewpoint of the crosswalk. The sidewalk slopes downhill from the crosswalk, leading to the accessible entrance which is about halfway down the hill. The slope of the path of travel and lack of curb cuts leading to the sidewalk pose barriers for disabled voters.

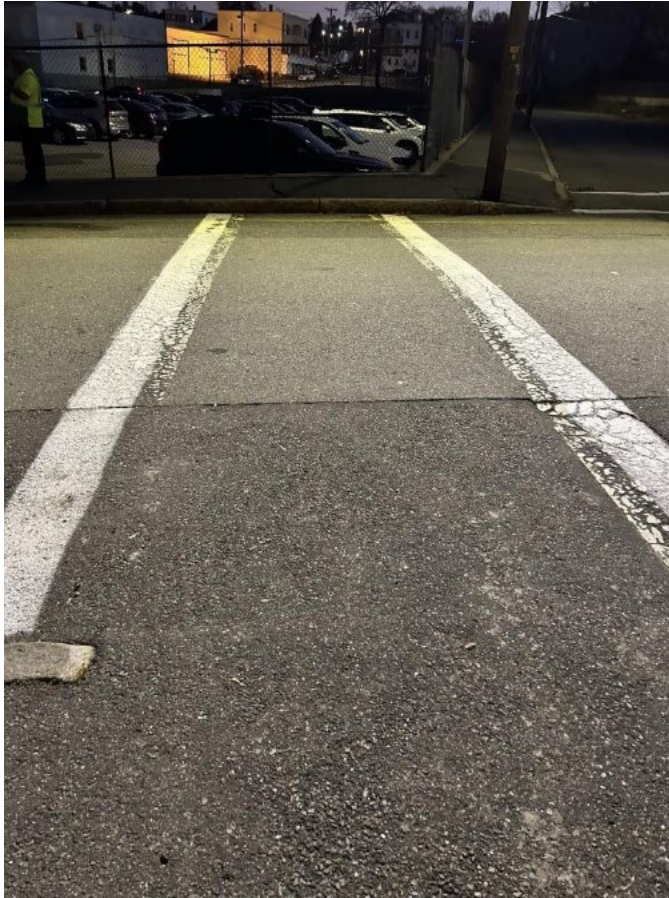
The crosswalk in the path of travel to the polling place. The crosswalk nearest to the parking lot has a curb a few inches high and lacks a curb cut/ramp.

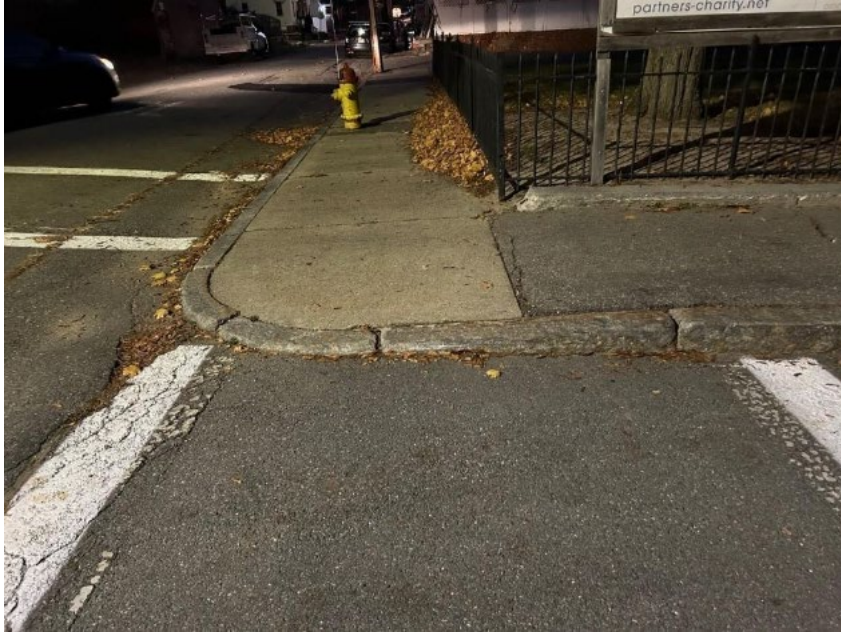
The intersection of two crosswalks. There is no curb cut, though it appears that the curb has been shaved down. The curb and pavement near the intersecting sidewalks are broken or cracked in some areas.

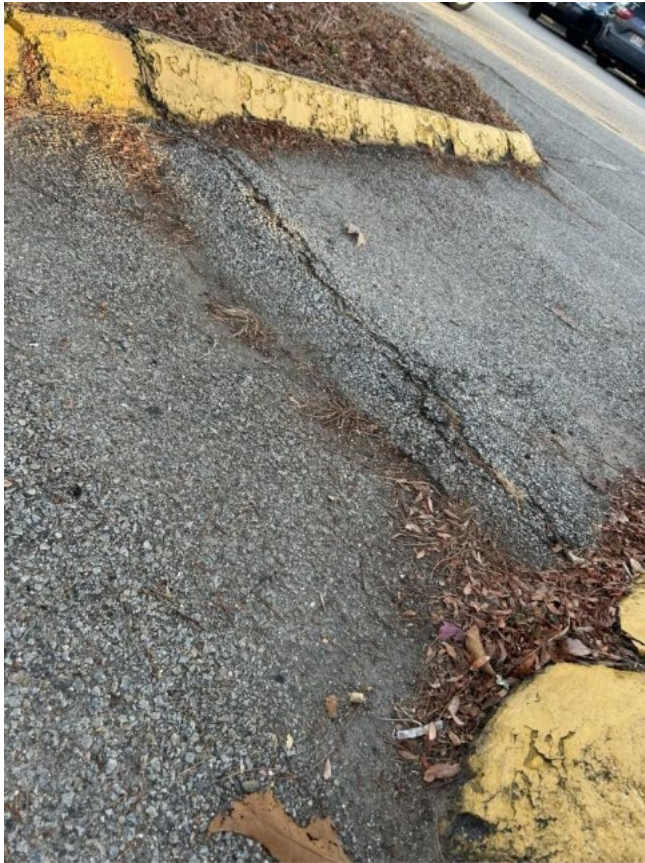
A raised patch of pavement leading to the Sturbridge Host Hotel. The pavement is raised by at least two inches, interrupting the path of travel.

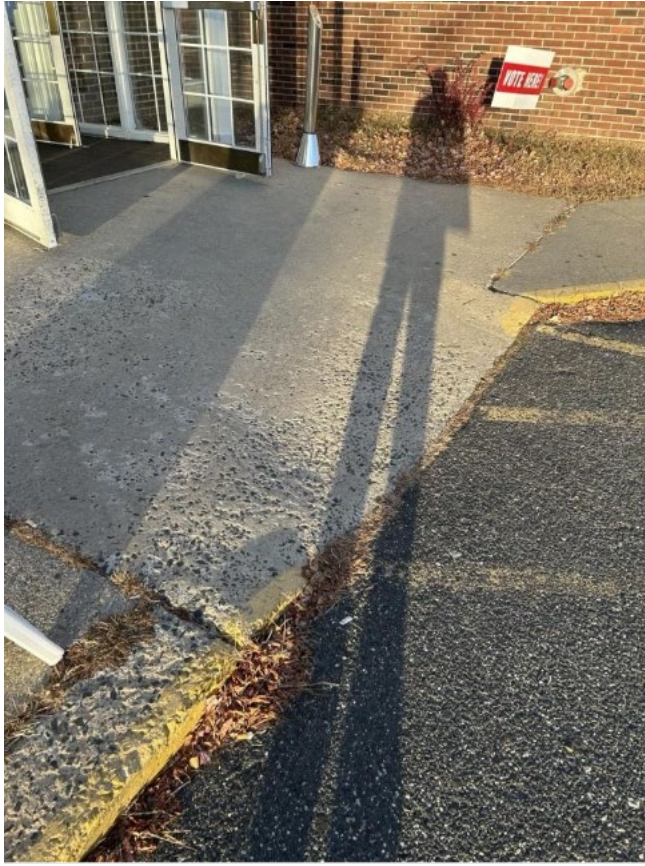
The path of travel leading to the Sturbridge Host Hotel. The sidewalk curb is lined with yellow paint marking the curb and a curb cut. The area where the sidewalk and pavement meet have some cracks, and the curb cut appears to be unmarked by any paint or tactile pavement.

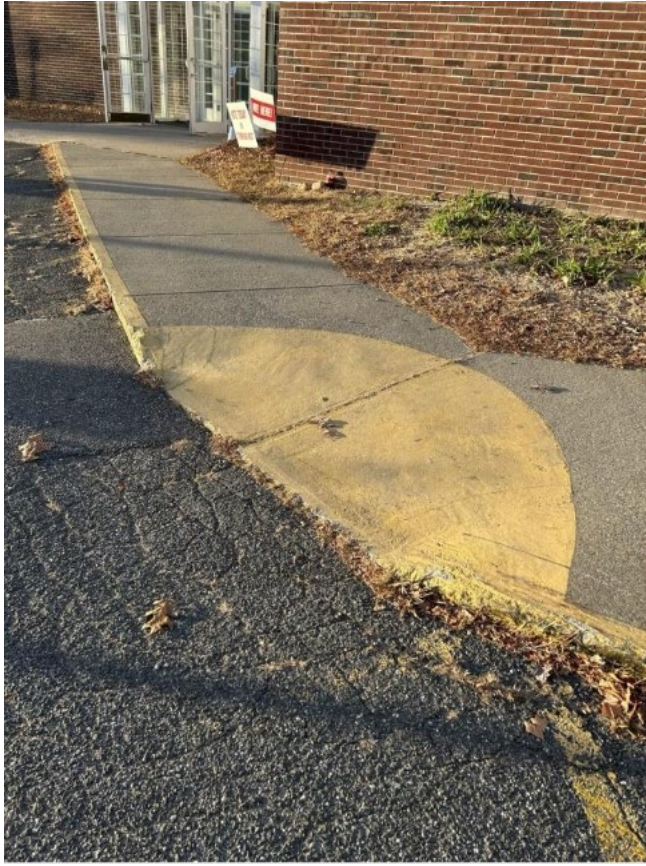
Sidewalk leading to the Sturbridge Post Hotel with a makeshift curb cut. The threshold between the curb cut and parking lot interrupts the path of travel.
